**Broyles and Associates**  
structural engineers

Re.: Dollar Tree – Western Plaza, 2085 N. Marine Blvd., Jacksonville, NC 28546  
Structural Report on Findings, Site Visit (April 14, 2015)

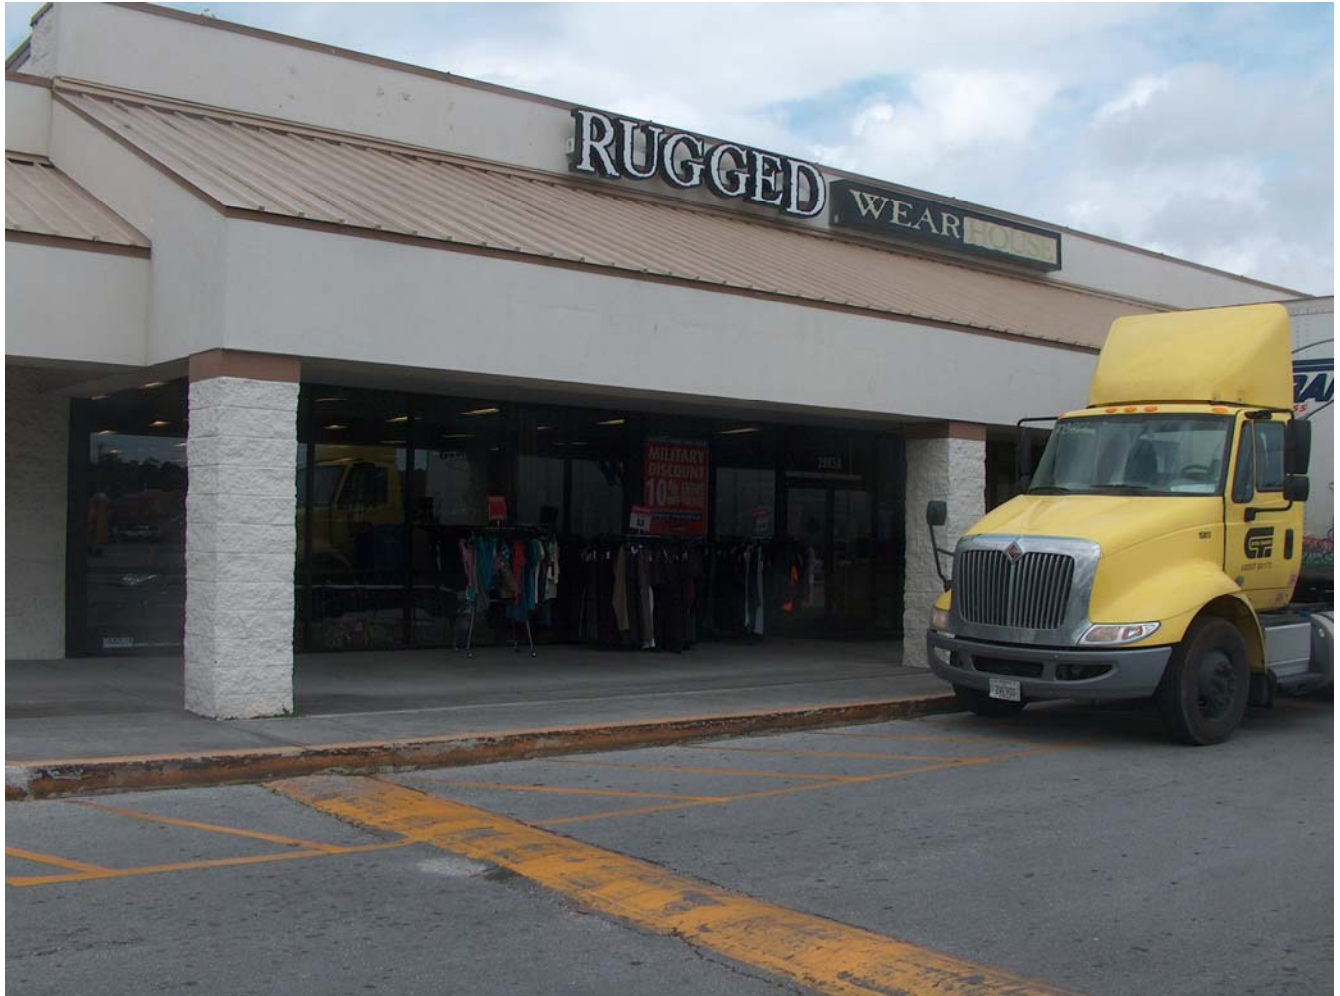
Photo #1 – Proposed Dollar Tree location – current Rugged Wear House located within a strip of shops at the Western Plaza, Jacksonville, NC.

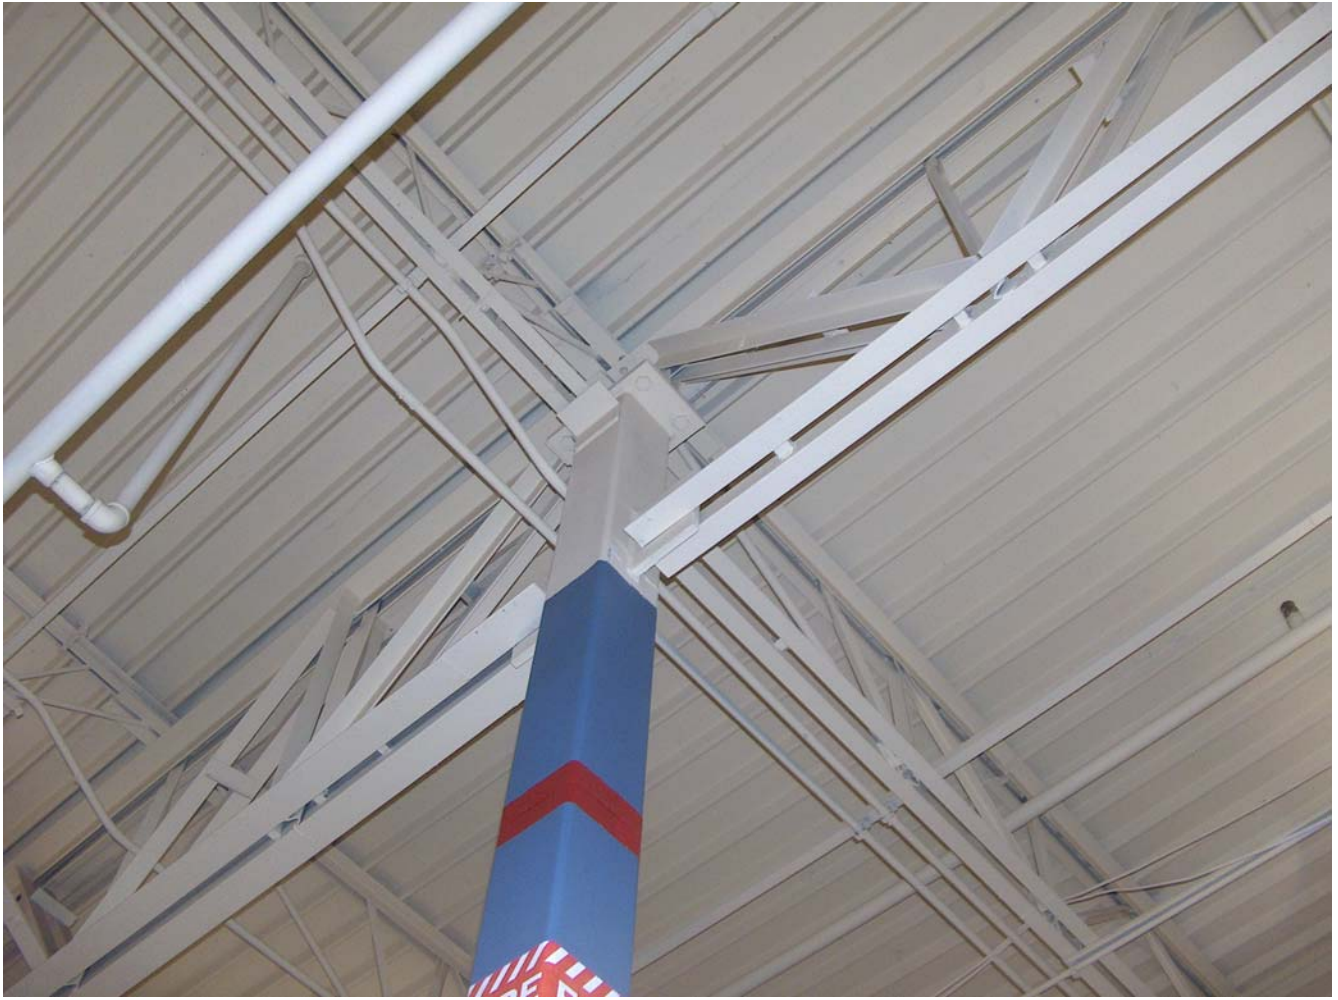
Photo #2 – Interior HSS6X6 steel column supporting 32” deep joist girders, steel bar joists and metal decking. There is no ceiling located within the proposed Dollar Tree space.

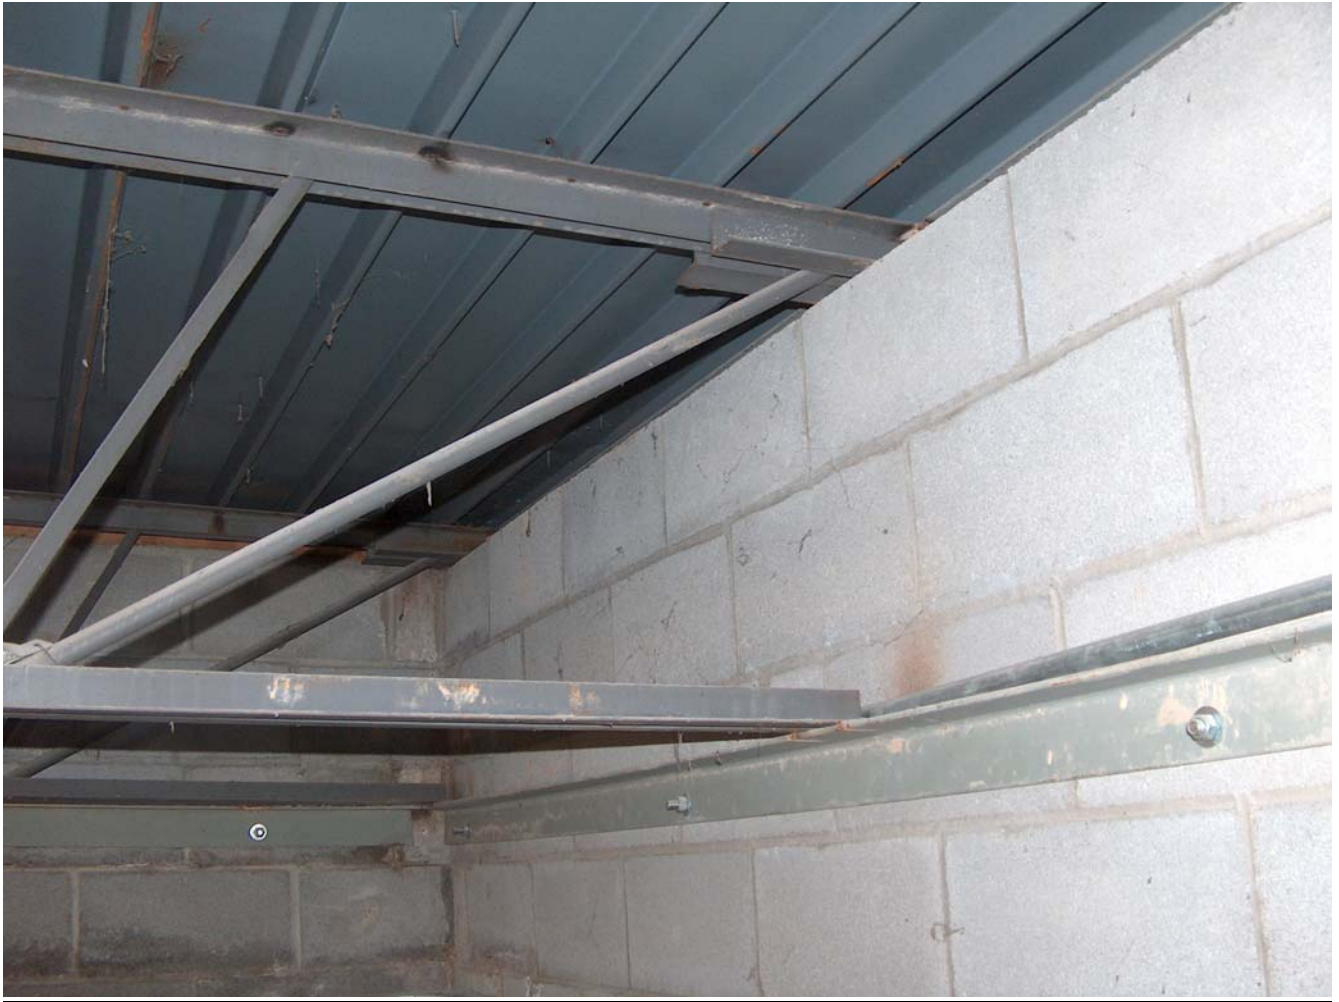
Photo #3 – Rear exterior 12" CMU load bearing wall with 22" deep joist bearing on top of wall.

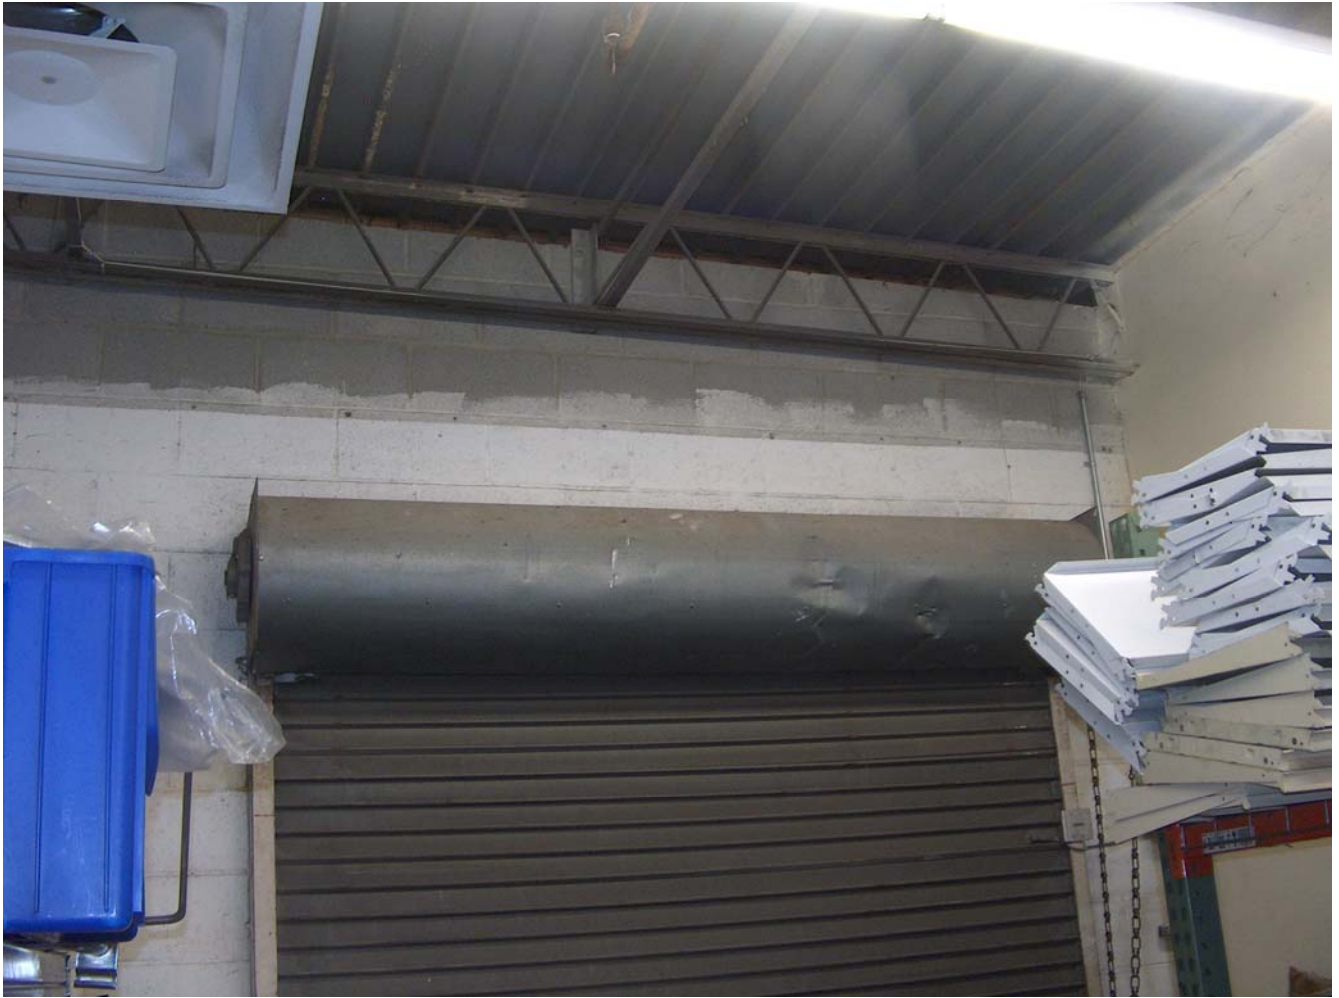
Photo #4 – Overhead door leading to exterior recessed truck ramp.  
Duel loading dock is divided with a metal stud demising wall.  
Dollar Tree would have access to loading dock closes to rear wall of  
building.

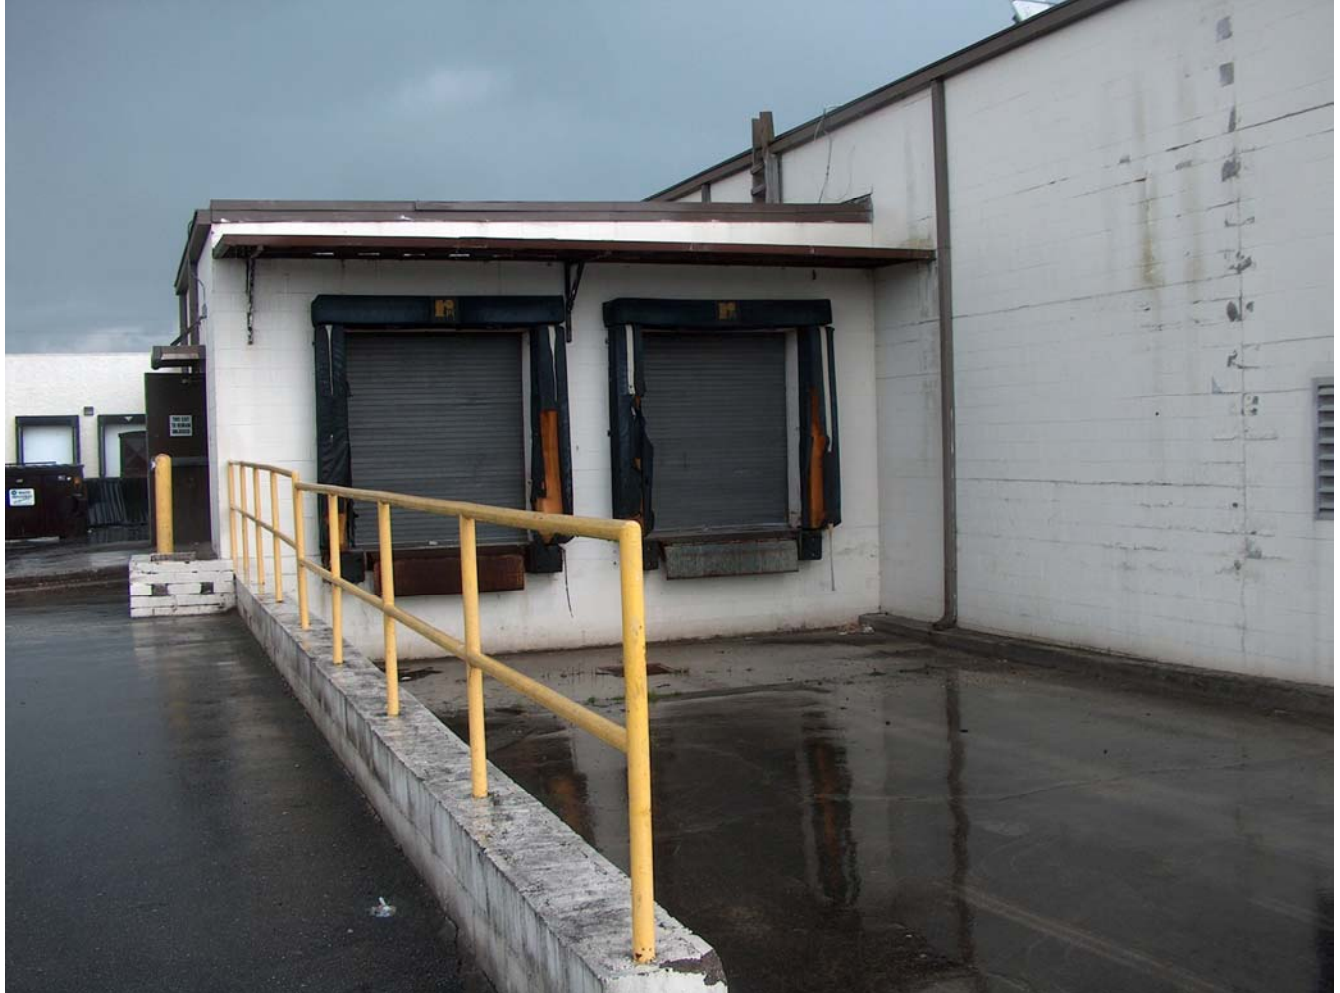
The loading dock currently receives product from trucks that back up inside the recessed truck well (See Photo #5). A sloped truck ramp is located directly behind the proposed Dollar Tree. The concrete ramp extends down to 4'-0" below finished floor elevation. There is a 12" CMU retaining wall on the open side of the ramp. Structurally, the wall appears to be in satisfactory condition.

Photo #5 – Recessed truck ramp and loading dock. Dollar Tree would have loading dock closes to exterior wall.

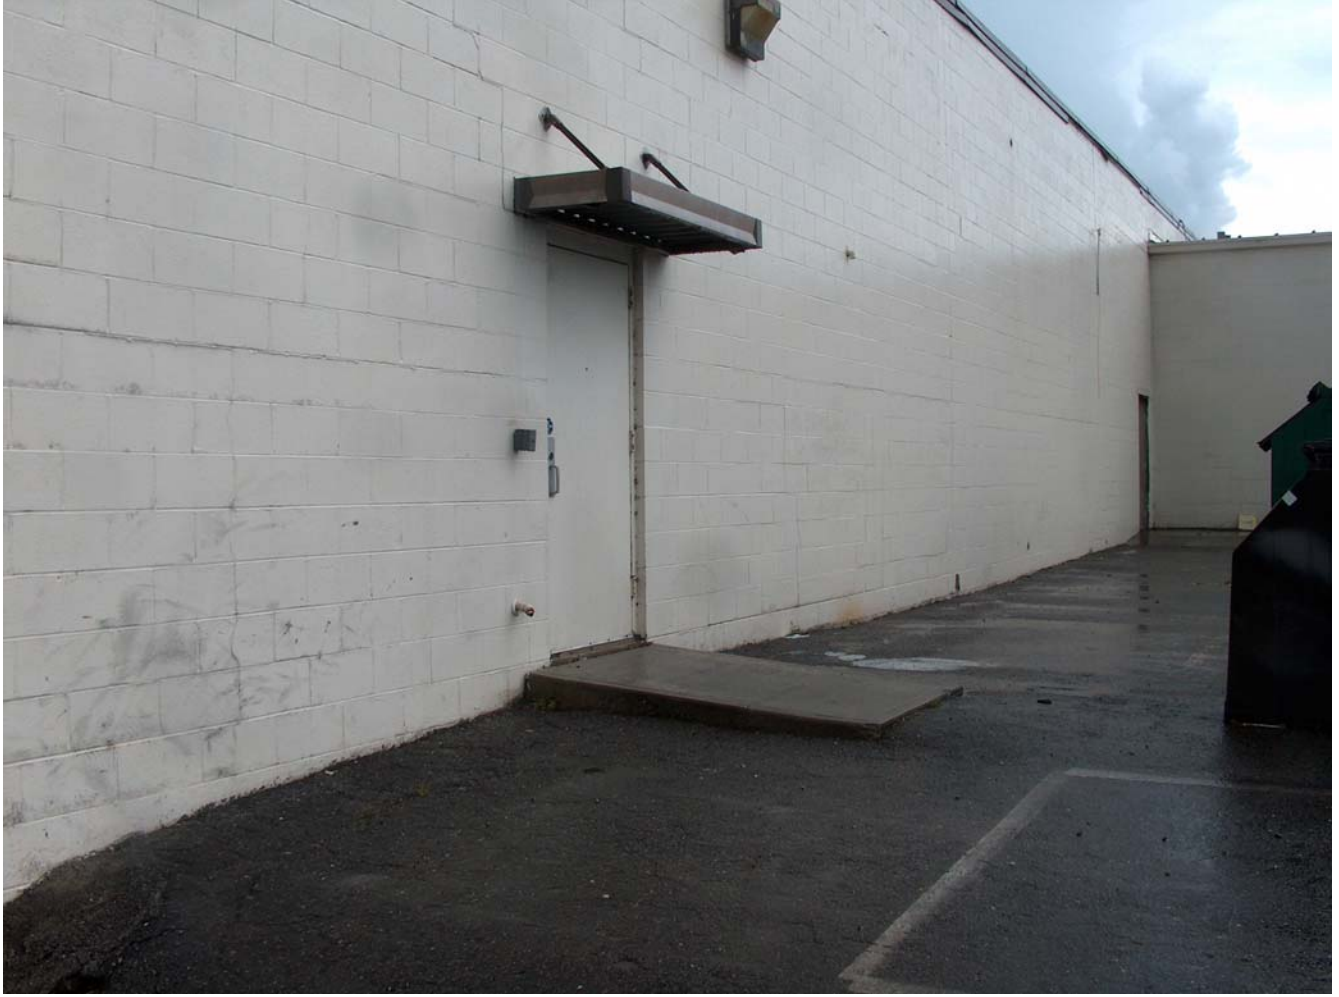
Also, please note that there are two (2) egress doors (3'-4") on the left side walls with concrete stoops (See Photo #6). Boot of the concrete stoops are approximately 8" above the surrounding asphalt grade. New concrete ramps will be required at the egress doors to match grade elevation.

Photo #6 – Egress door leading out from stockroom with concrete slab. Concrete slab is raised up from surrounding asphalt – typical for both exterior doors on this side of the building.

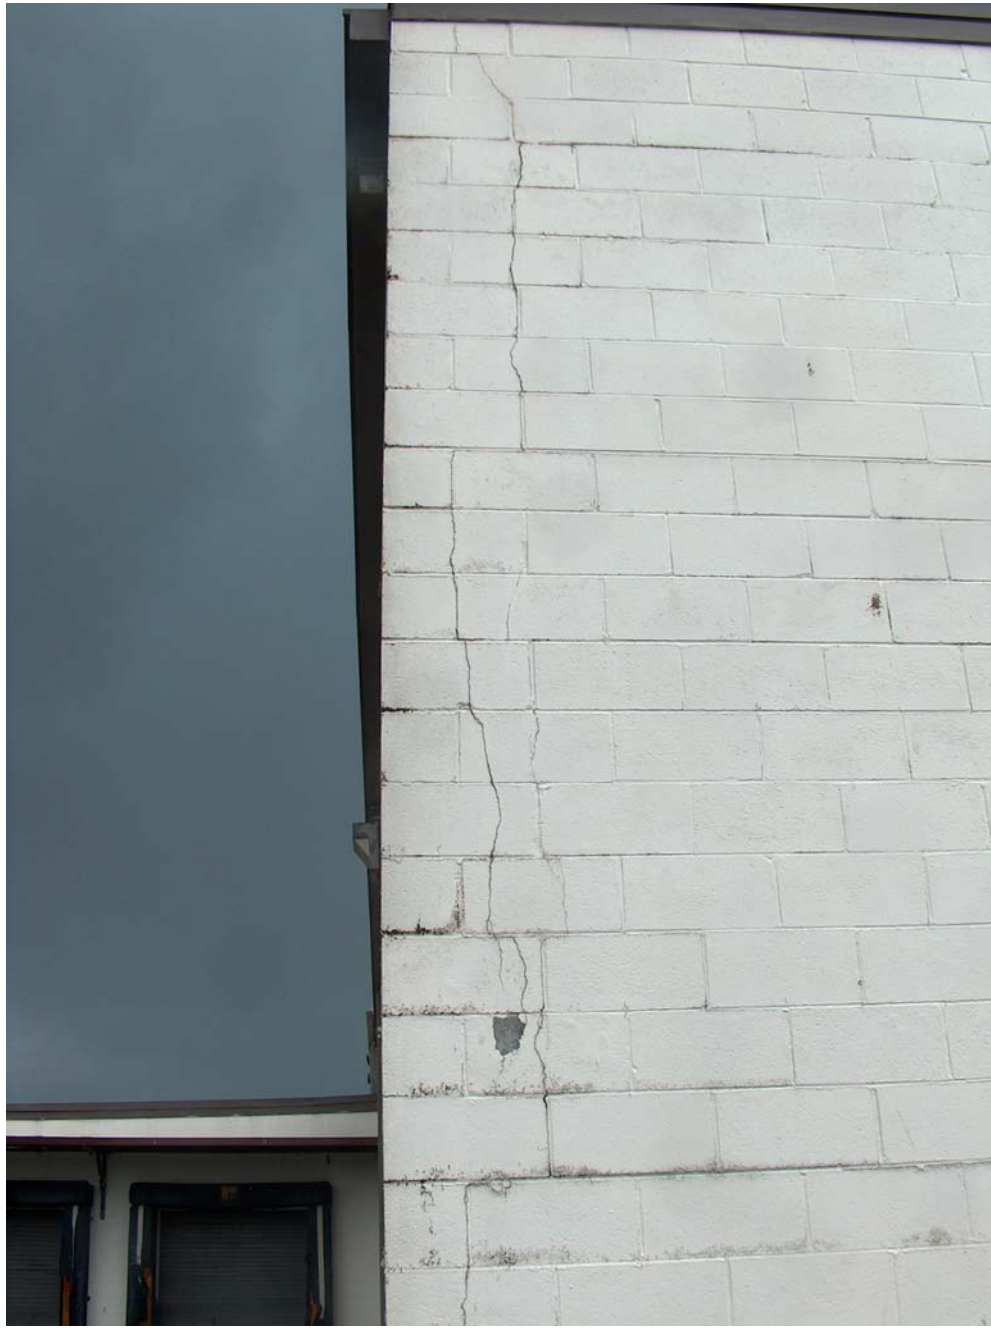
We did not quite a bit of cracking of the exterior CMU walls on the rear and left side walls. The crack at the corner of the wall (adjacent to the loading dock) is cracked for the entire height of the wall (See Photo #7). According to the current tenant, there is moss growing on the inside of the wall (a bit of an exaggeration, however, there is quite a bit of cracking). There is also cracking above both egress exterior door openings (See Photo #8). It appears that the cracks are relatively small but are open to the elements and allow water to enter the building. It appears that the cracks are from settlement and that the rear of building footprint was built up. We recommend that the landlord address the cracks and report as required. In the case where the CMU units are cracked, we recommend replacement and tooling back into the wall. Please note that the wall thickness on the rear and side walls is 12" and both walls are essentially bearing.

Photo #7 – Crack at rear corner of building extends for full height of wall. We recommend replacement of cracked CMU and repointing. This is typical of several areas on the rear and side walls.

As noted above, the major structural issue with existing building (Dollar Tree portion) involves the exterior masonry cracking – particular around the rear corner of the building. We recommend that cracked CMU be removed and repointed back into place. There are other cracks too that need to be repointed along the rear and side walls. This is needed to prevent water infiltration into the stockroom and sales areas. If new mechanical units are replaced, we recommend that they be located at the existing locations – if possible. Some steel support may still be needed depending upon the size and location of units. There will need to be some remedial work done at the egress doors. A new concrete ramp and landing is anticipated. The recessed truck well and loading dock can be used for Dollar Tree without any modification. We recommend some remedial work be done over the lintel beam heading into the loading dock area.

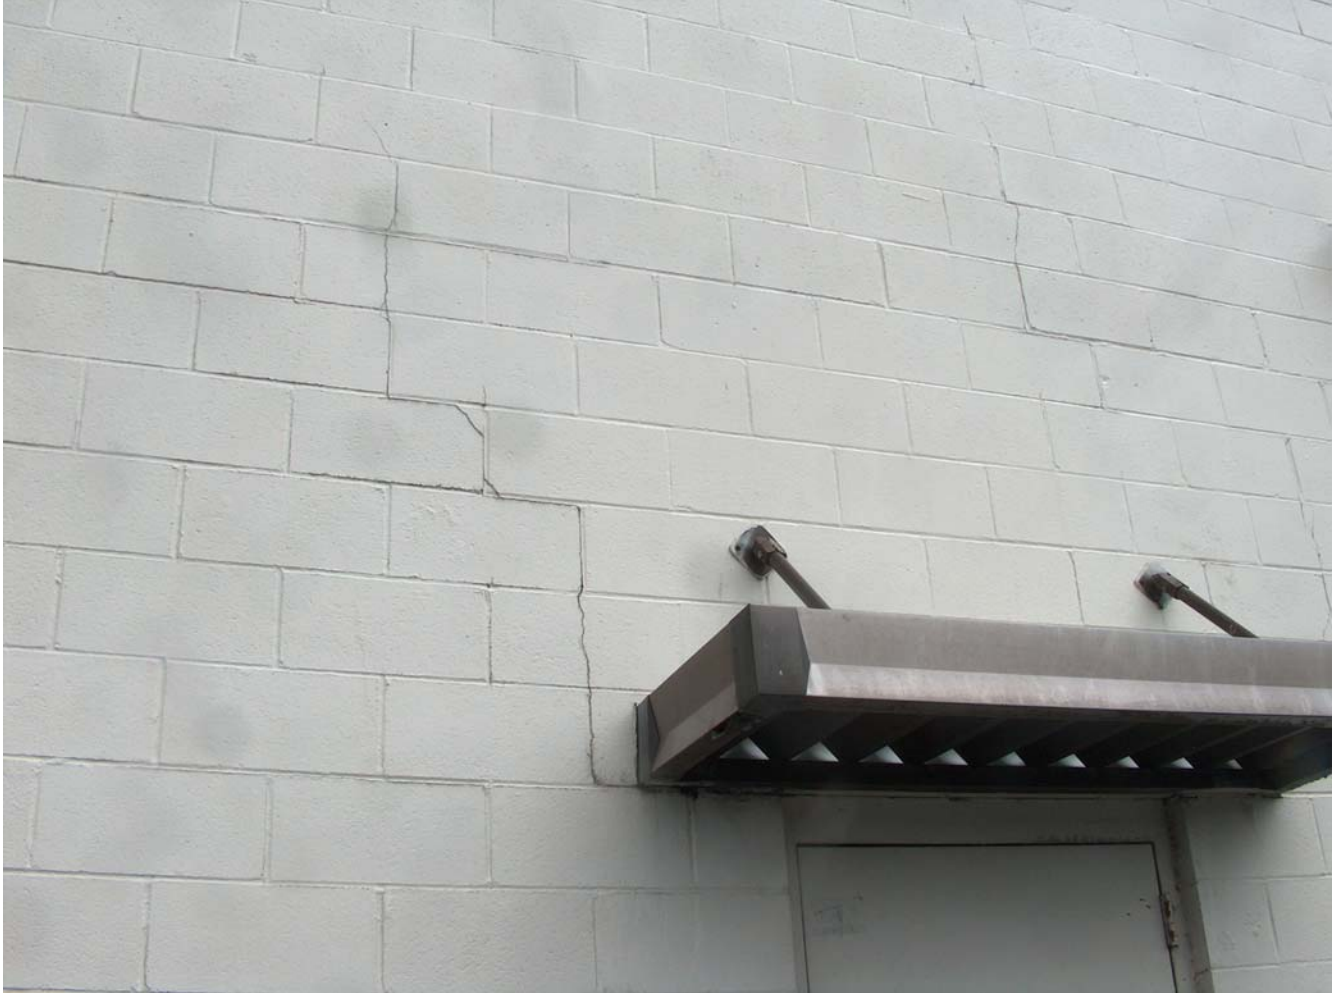
Photo #8 – Cracking of CMU side wall above personnel door –  
typical for both doors.

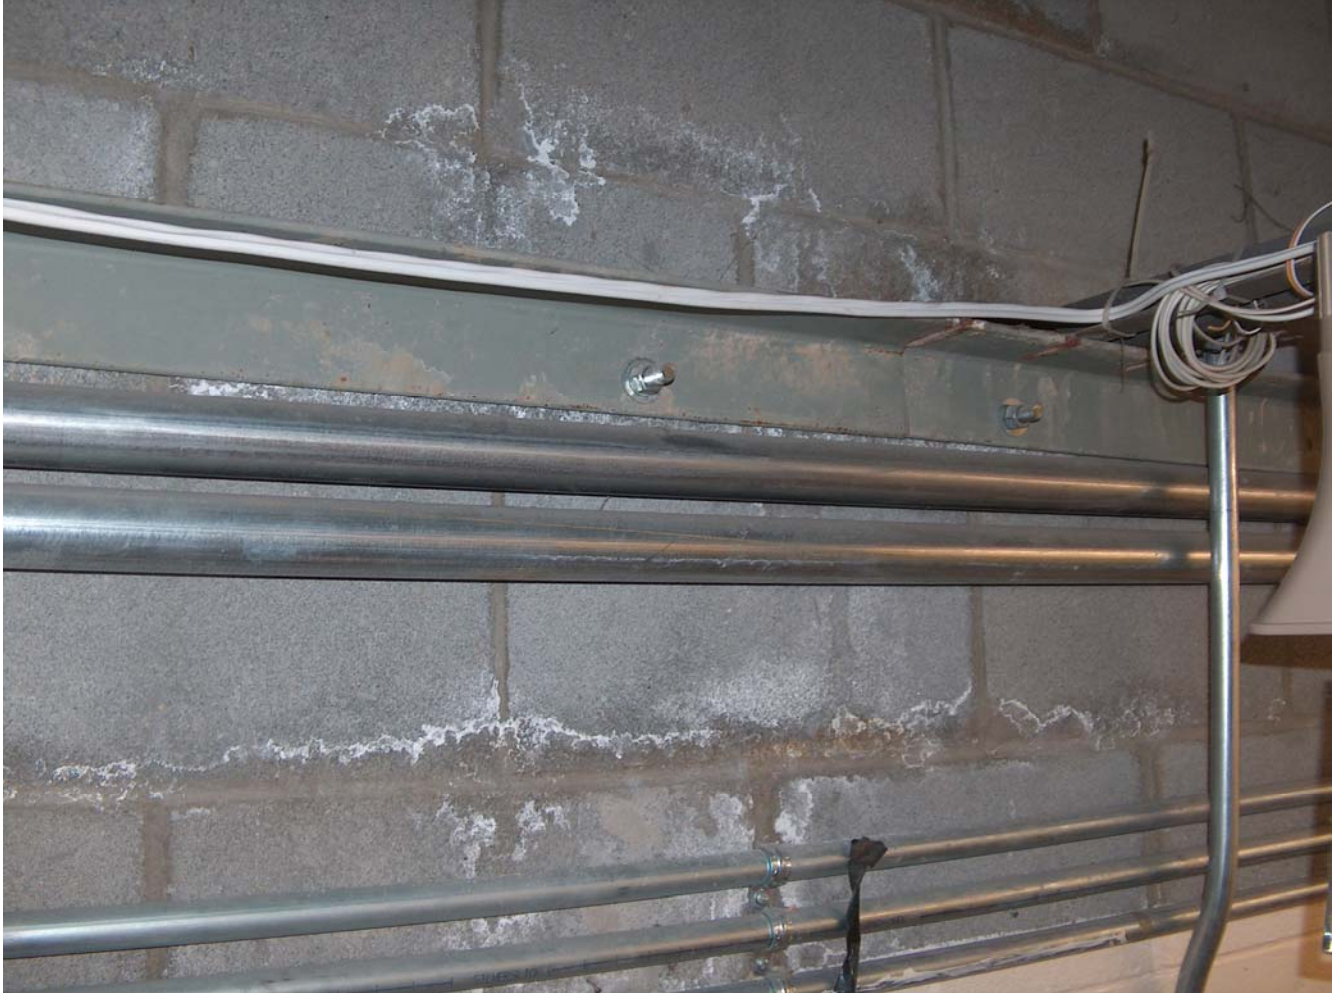
It is also obvious that water has been getting inside the wall cavities (efflorescence is visible on the inside of the walls) (See Photo #9). This is due to the aforementioned cracking and at least two downspouts are missing from the rear gutter. The water cascades down the outside face of the CMU. We understand that the landlord has already been informed of the missing downspouts.

Photo #9 – Efflorescence located on inside face of CMU rear bearing wall. Water has been getting inside wall cavity.

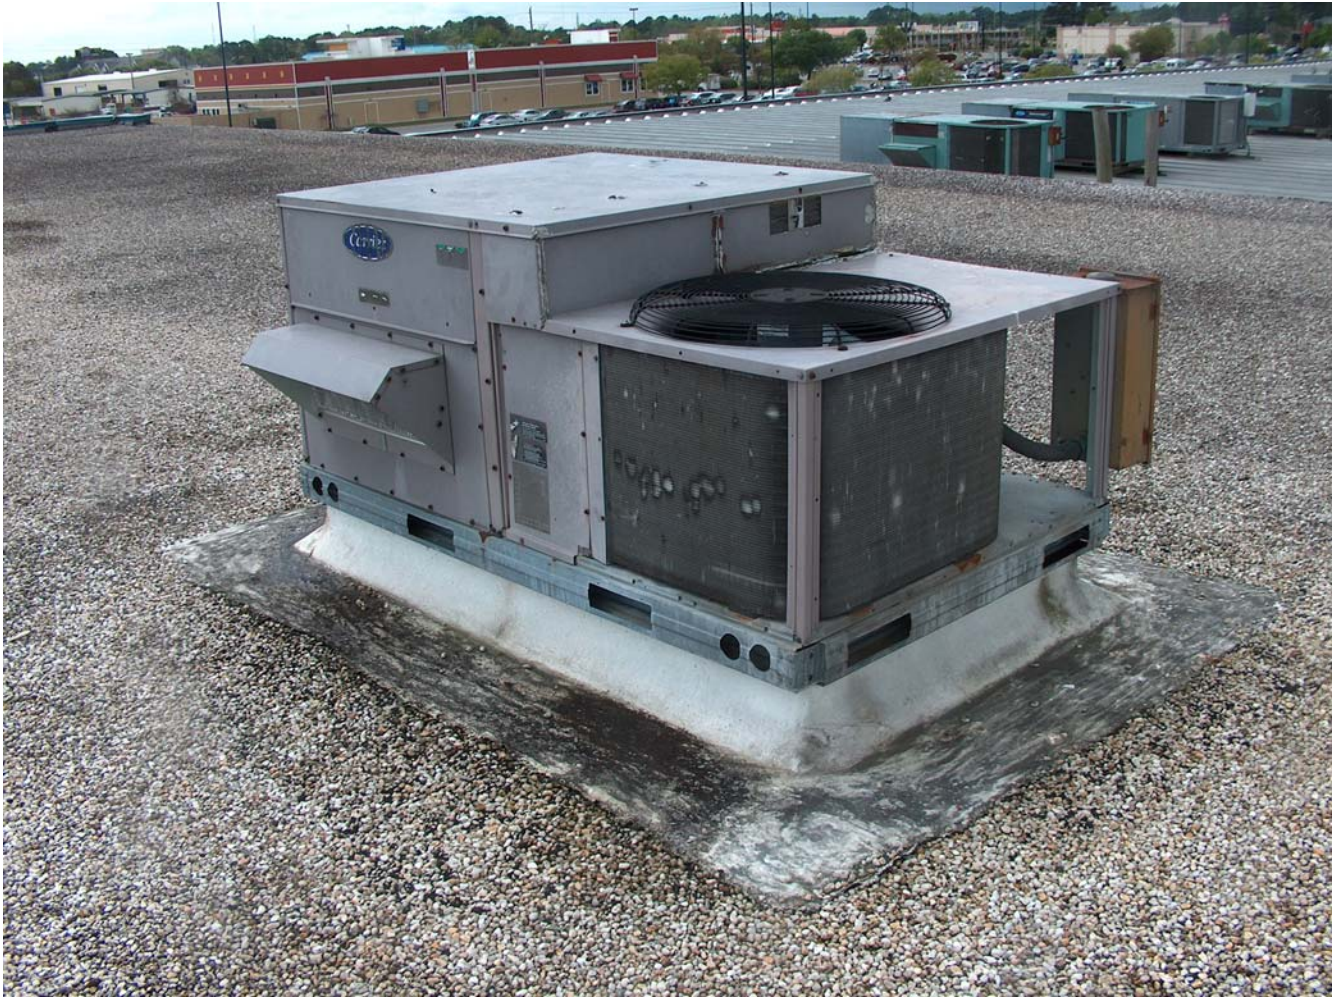
There are currently seven (7) mechanical roof top units over the proposed Dollar Tree space (See Photo #10). There are four (4) original Carrier units and three (3) additional Trane units that must have been added later during a renovation. One of the rear Trane units does not have any steel angles supporting it beneath the roof structure (See Photo #11). The other RTU's do have structural steel angles below them and appear to have been designed initially or in good locations. The units appear to be fairly worn and may need to be replaced. We recommend that the mechanical engineer reuse the existing locations as much as possible to minimize the structural impact.

Photo #10 – Existing Carrier RTU located over proposed Dollar Tree space. There are 7 units total – a combination of Trane and Carrier. This unit appears to be in an original location.

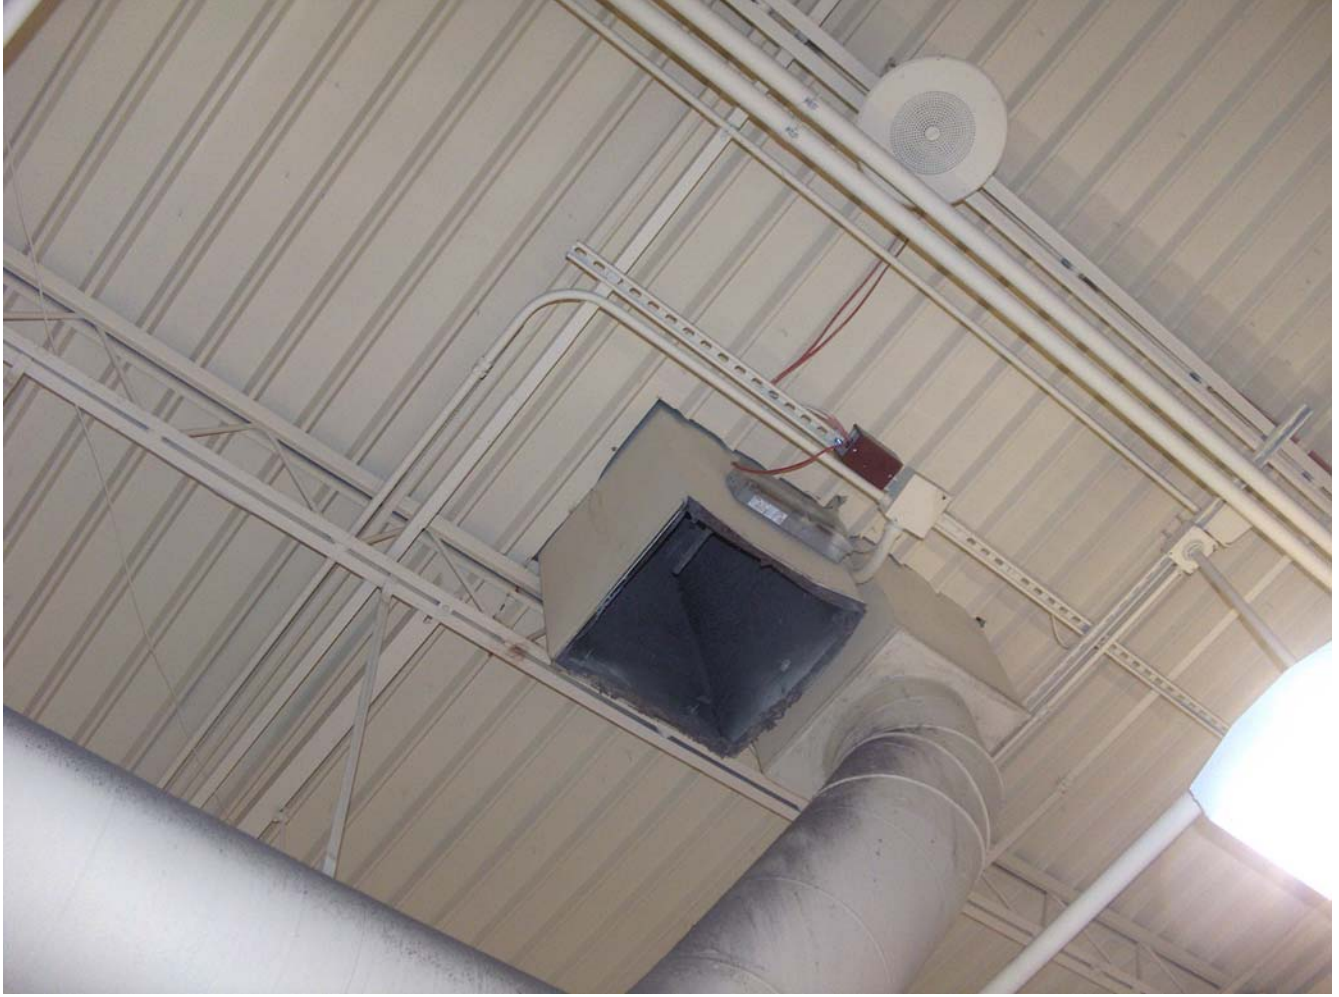
Photo #11 – Rear Trane RTU with no support below existing curb.

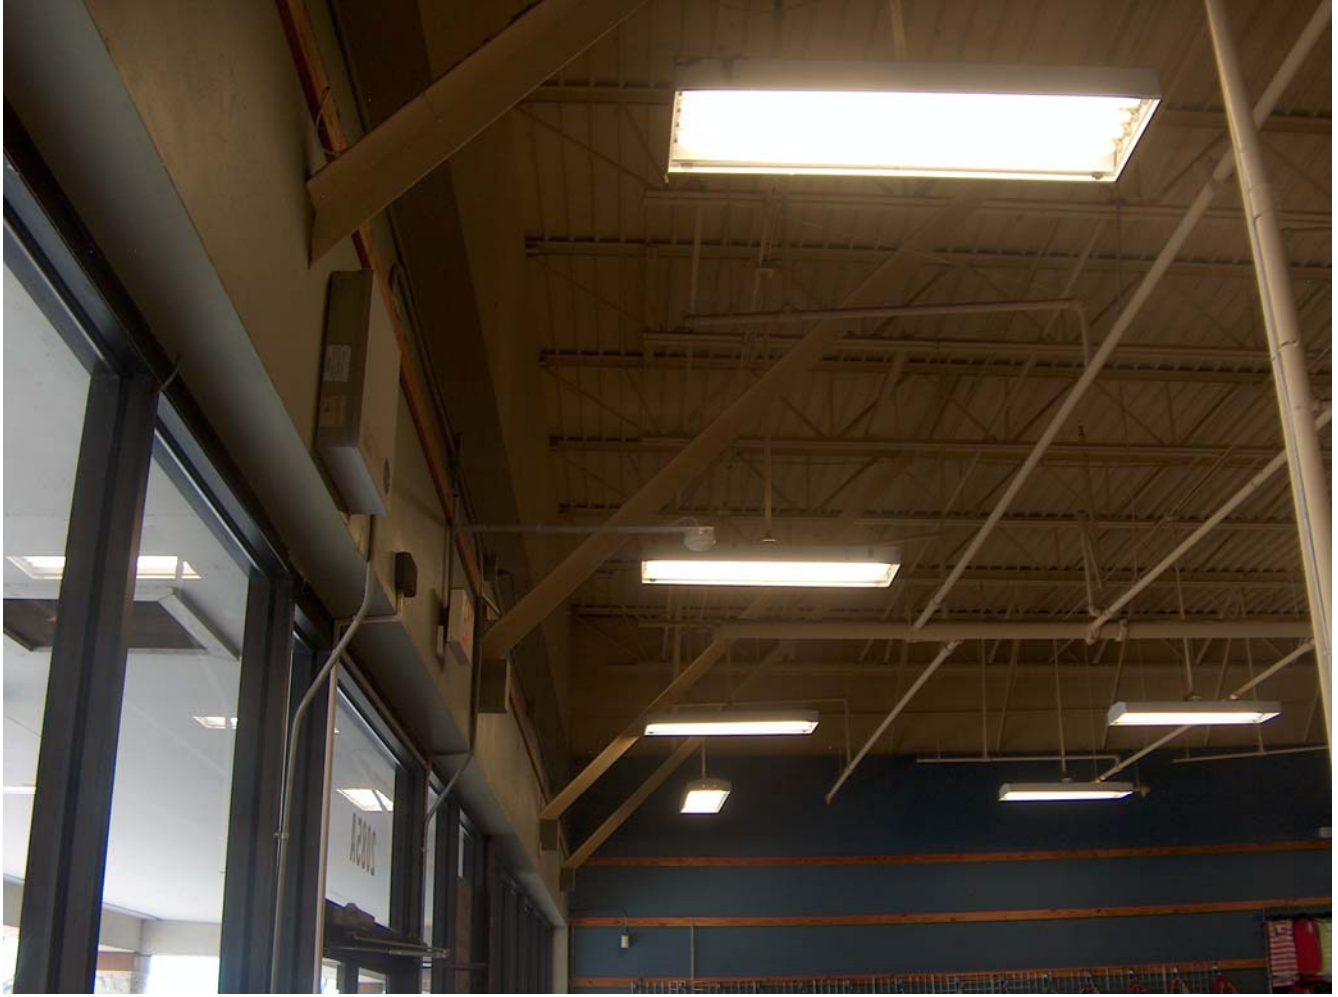
Photo #12 – Steel L3X3 braces extending up from lintel beam over storefront to roof structure above. The angles may be exposed if Dollar Tree provides a new ceiling.

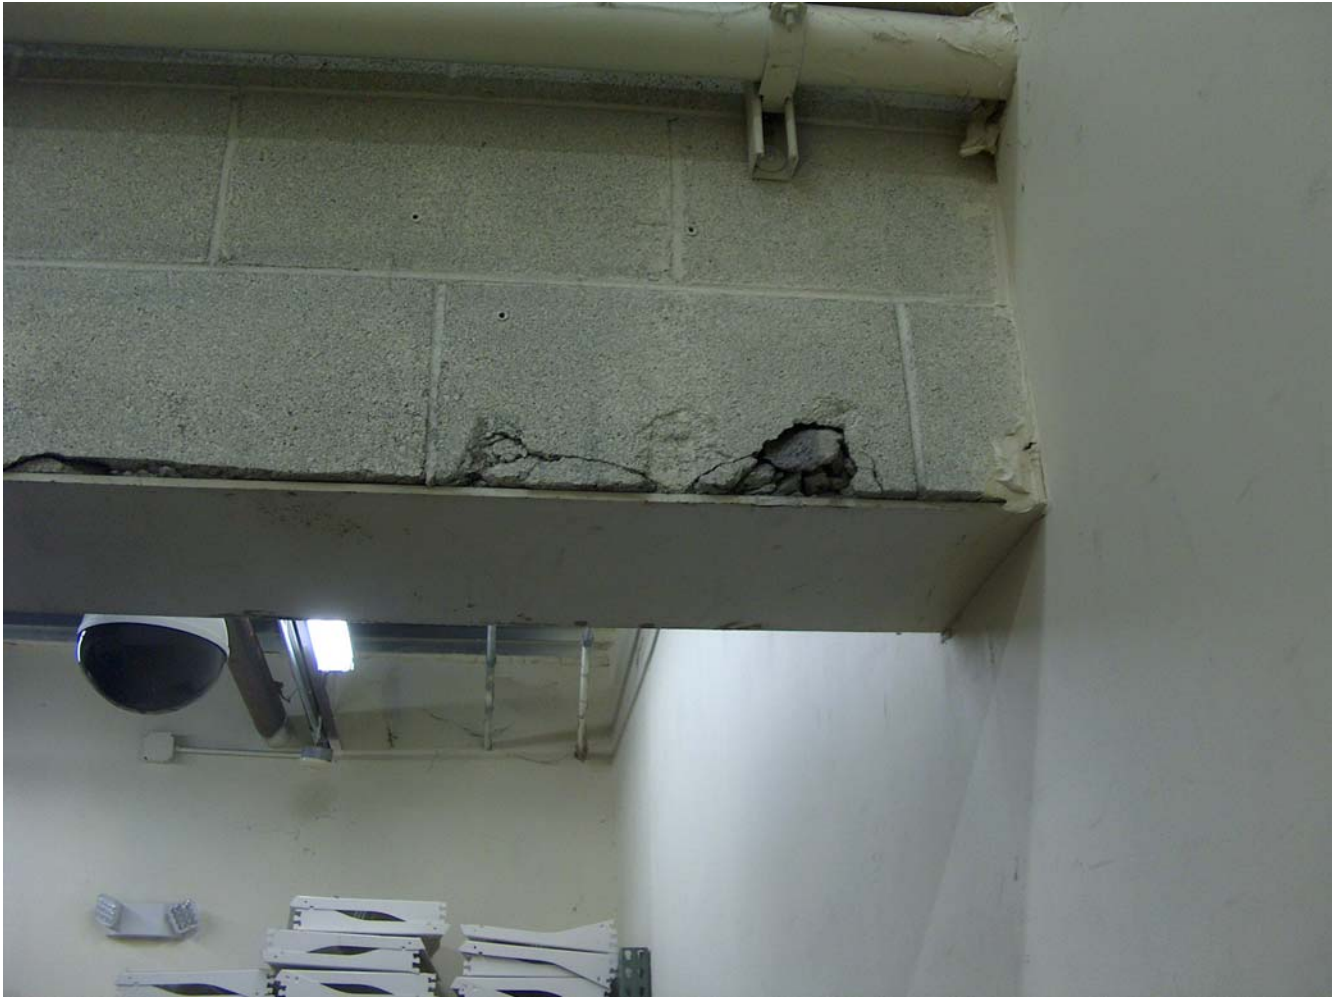
We did note that there was some cracked CMU above the lintel plate where the proposed Dollar Tree store enters the stockroom space (See Photo #13). The steel beam extends approximately 6'-3" with this space. We recommend that the landlord remove the cracked CMU pieces and place grout on both sides as required to maintain bearing on the lintel plate. Please note that this is fairly minor.

Photo #13 – Cracked CMU face shell above steel lintel plate around the rear stockroom entrance. We recommend that the broken CMU be replaced with grout to maintain bearing.
