**Broyles and Associates**  
structural engineers

Re.: Dollar Tree – D10537 Midway Marketplace 189 Hickory Tree Rd, Winston-Salem, NC 27107  
Structural Report on Findings, Site Visit (May 17, 2017)

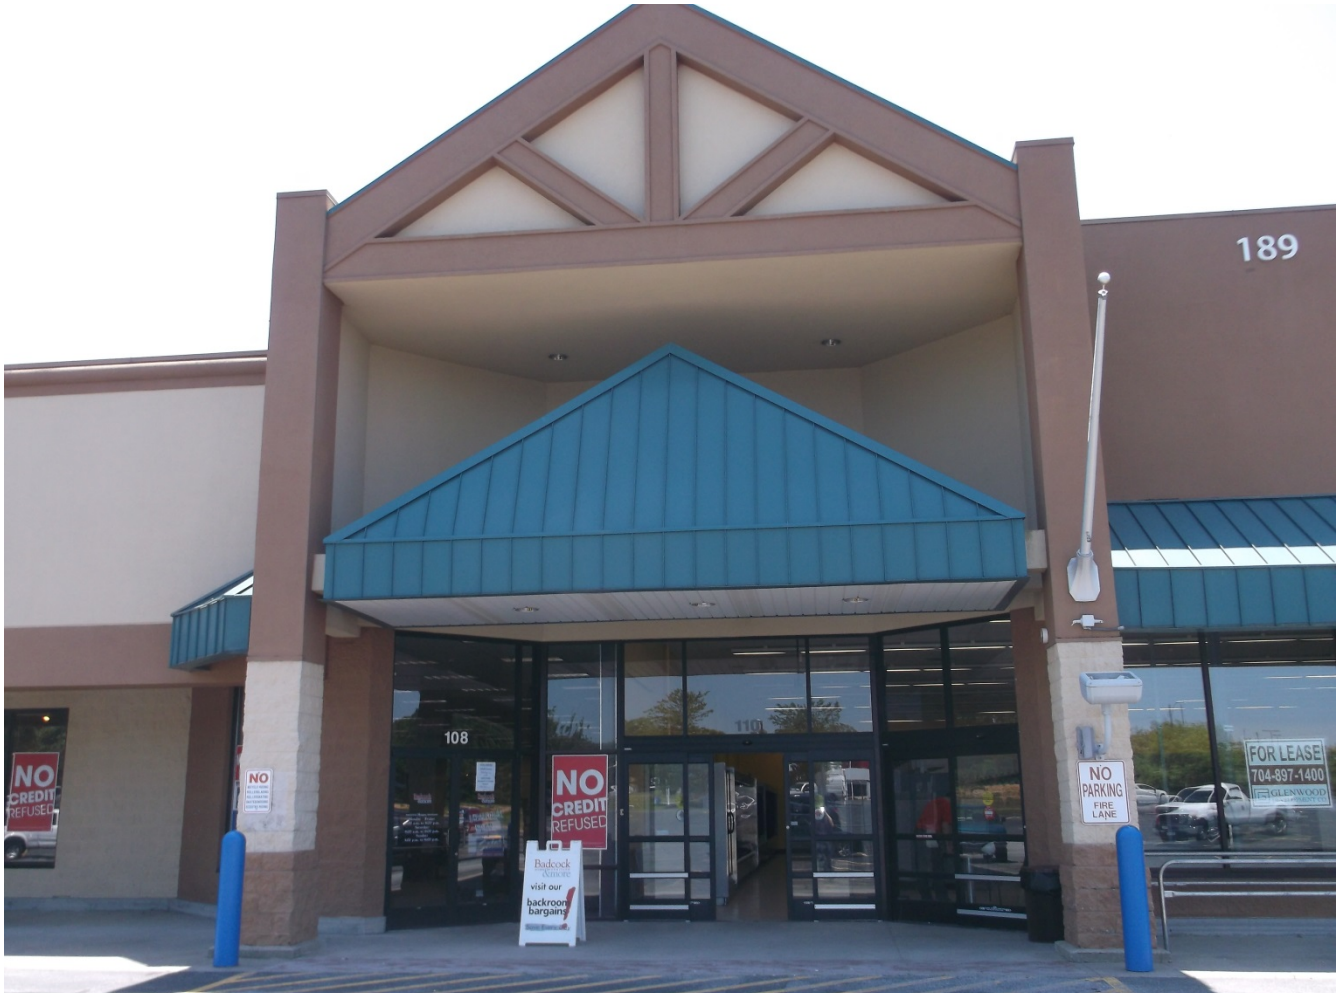
The proposed Dollar Tree is a former Walmart Express located in the rural setting of Winston-Salem, North Carolina (See Photo #1). The building is a part of a marketplace strip with high parapet walls and a roof access hatch in the rear of the unit adjacent. The building is in great structural shape. There were no structural deficiencies found during our investigation, except for effervescence on the CMU walls near the loading dock (See Photo #2). We believe the building to have been constructed in the 1970's and renovated in the 2000's.

Photo #1 – Former Walmart Express – exterior of front of building. The unit is next to Bedcock Furniture in a Marketplace in Winston-Salem, NC. There are three structural steel columns and splitface CMU wraps at the front of the building.

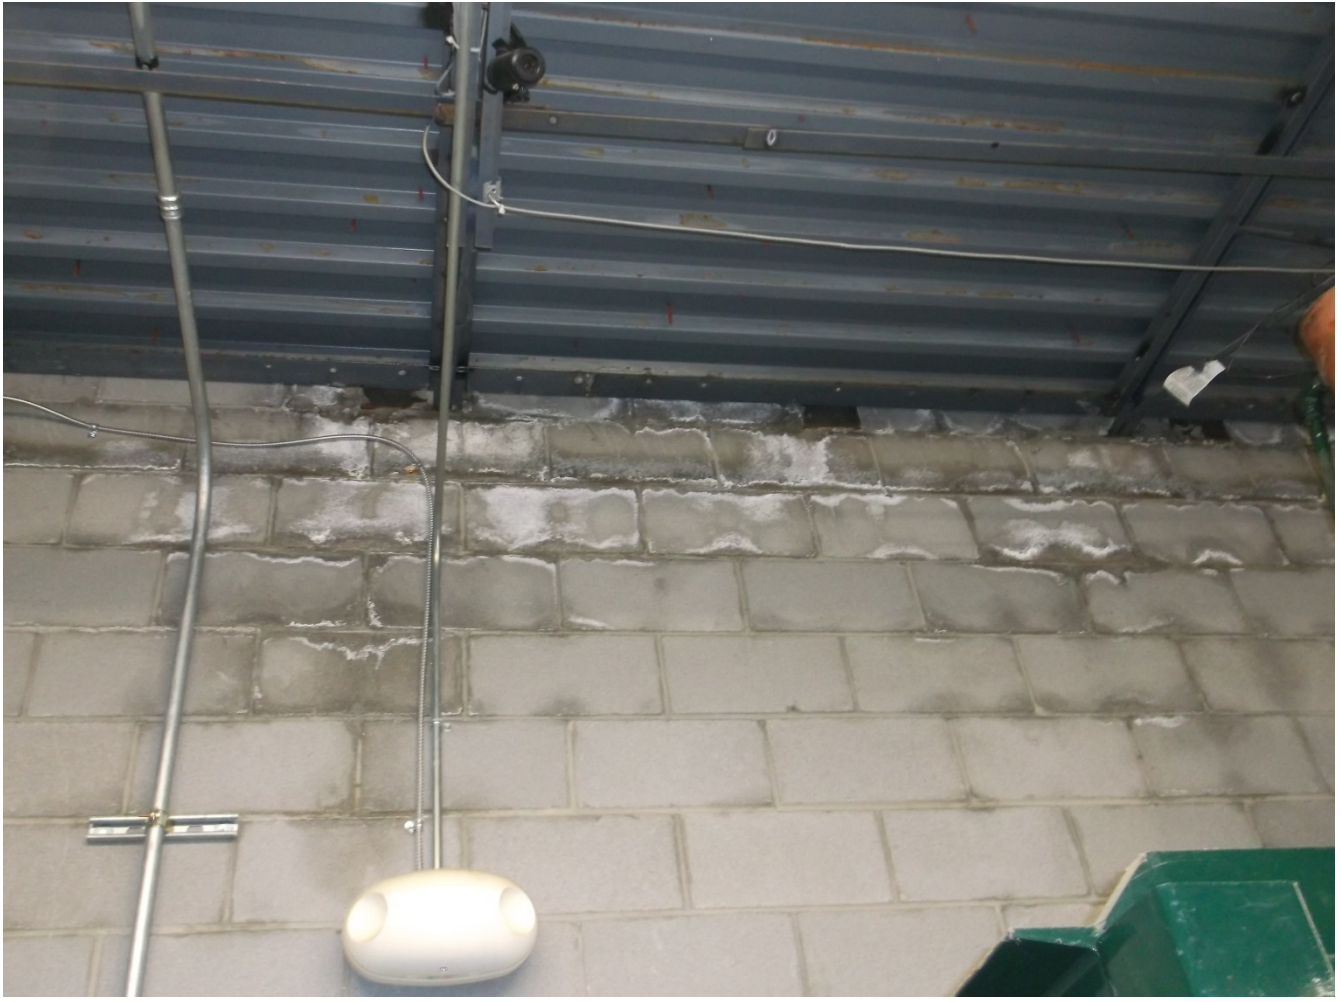
Photo #2 – Effervescence in the back loading dock areas on the concrete walls. The effervescence seems to be concentrated in the wall opposite to the loading dock overhead door. This was an additional that Walmart provided when they took over this space.

As mentioned above, this building is in great structural condition with no known structural deficiencies minus effervescence on the back CMU walls. If new mechanical units are to be provided, we recommend that they be located over the existing RTU locations. The front exterior wall consists of 6" metal stud framing and wood framing veneer. Please note that this front wall is load bearing and would need to be modified for additional storefront doors. There are steel framed joists along with CMU masonry in the rear of the building. The store seems to be a great fit for the proposed Dollar Tree with little fix-ups and ready use.

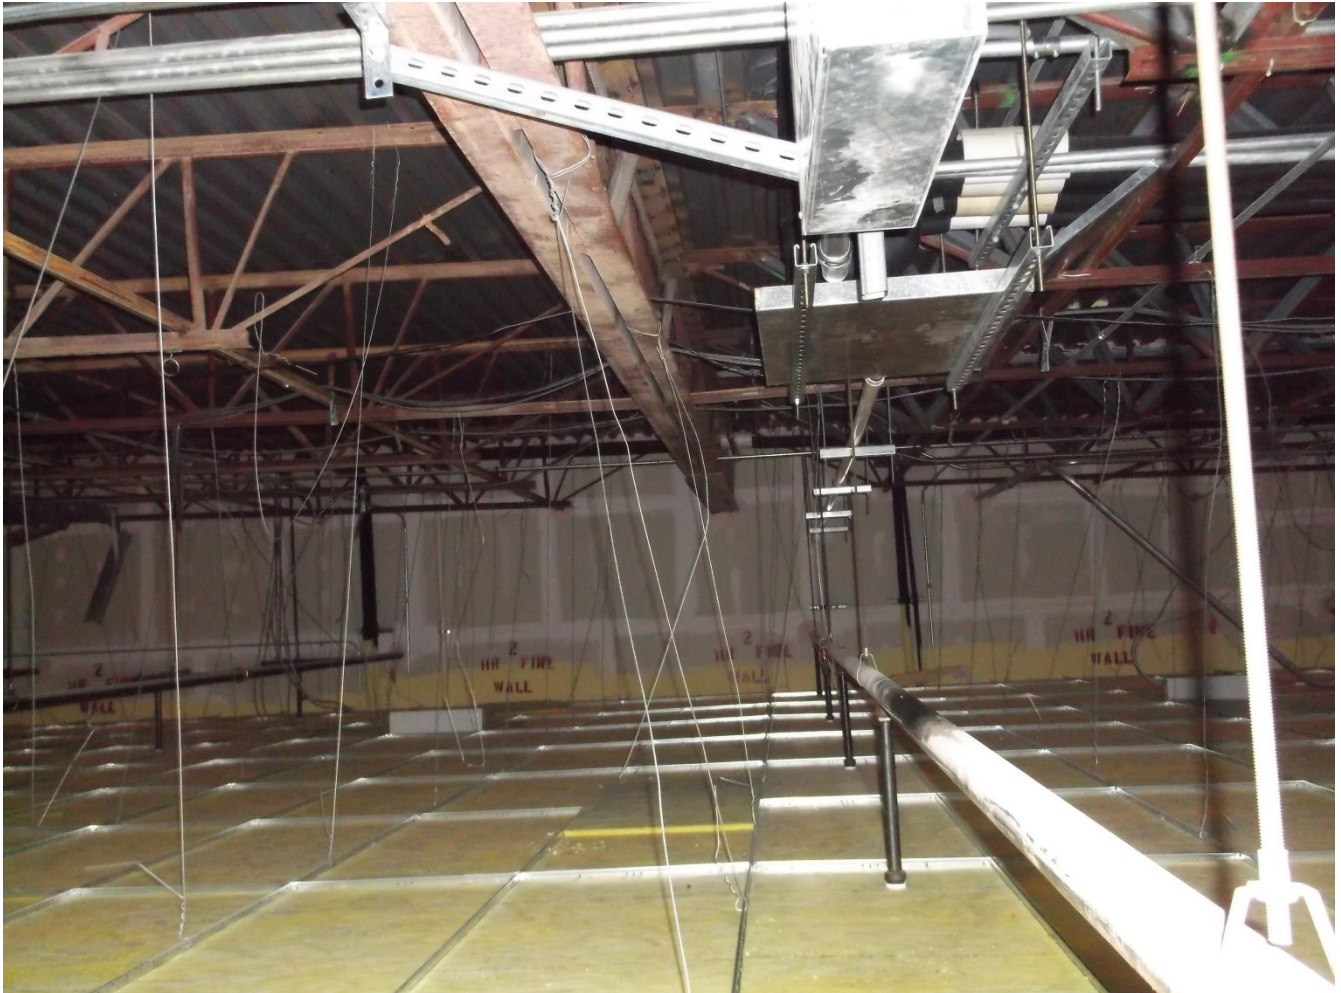
The building is steel framed with two 24" deep steel truss joists until reaching the column at D7 on the S3 Steel Roofing Plan and then two 44" deep steel truss joists that span the rest of the length of the building (See Photo #3). The truss girders are comprised of double L4X4X1/4 top and bottom chords. They bear on steel columns along with the CMU demising wall on the sides of the building space. The deep steel bar joists are typically spaced at 5'-3" on center running front to rear of the building. The metal deck is a wide rib deck and is in good shape. There is a lot of mechanical and electrical piping that hangs down from the roof deck, especially in the rear of the retail space (See Photo #4). Even though this clutters up the top of the ceiling, it is in good shape and is not a structural concern. There is however, effervescence on the CMU wall in the loading dock room. It does not appear to have caused significant damage, but the roof should be checked for leakage. Again besides the effervescence, there are no structural concerns noted with the roof structure.

Photo #3 – Steel joist girders extending from side to side of the retail space. Once the joists reach the first column line in the proposed Dollar Tree, the steel joist depth increases from 24” to 44”, due to the RTU’s and other ceiling fixtures on that side of the building.

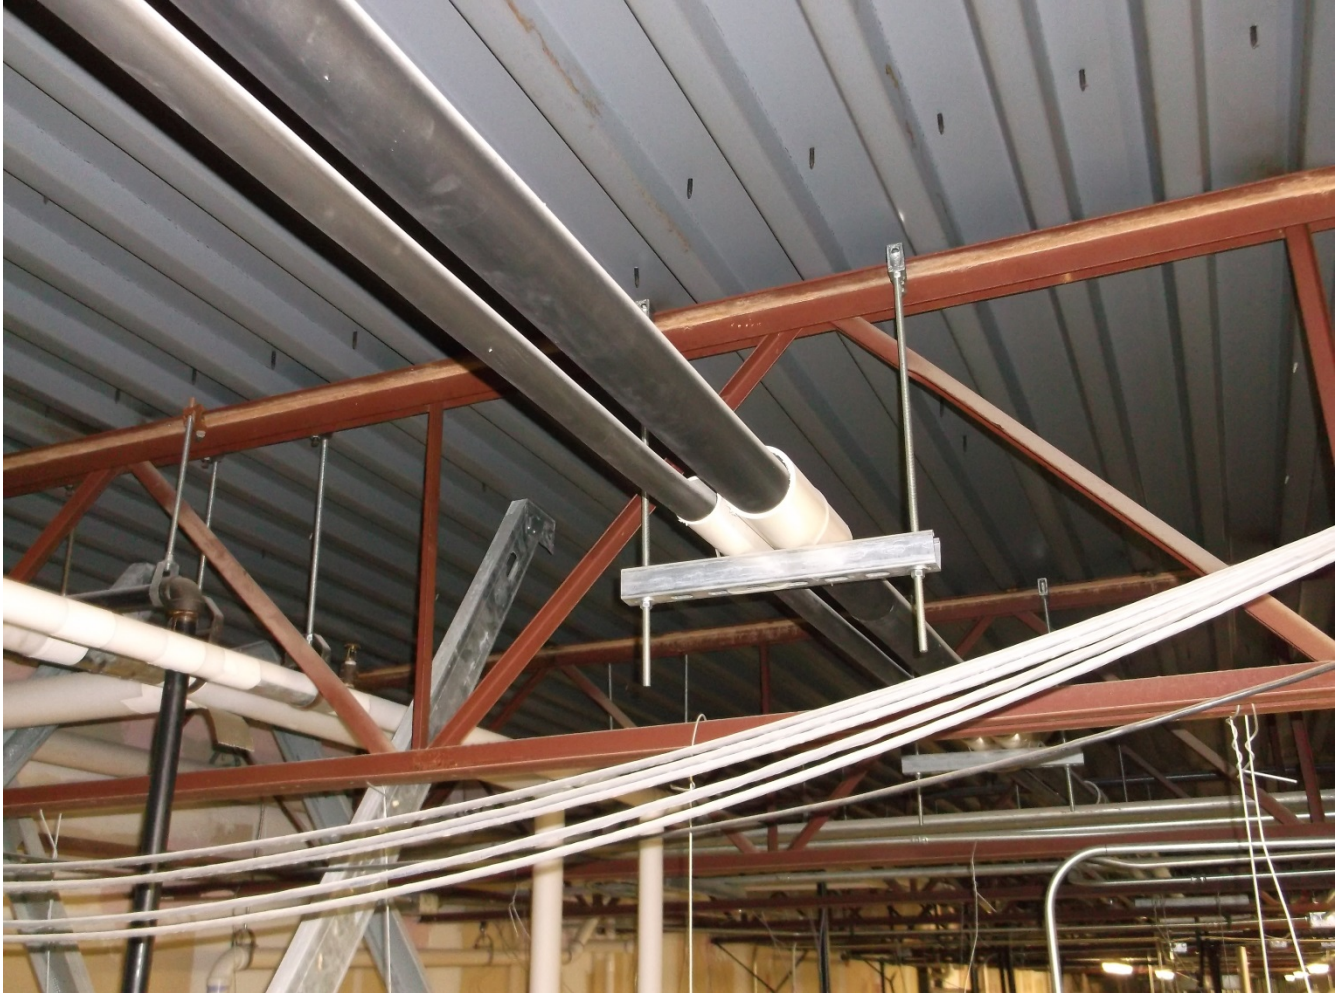
Photo #4 – Exposed rear corridor ceiling. The ceiling was covered with mechanical and electrical piping, along with other hanging fixtures.

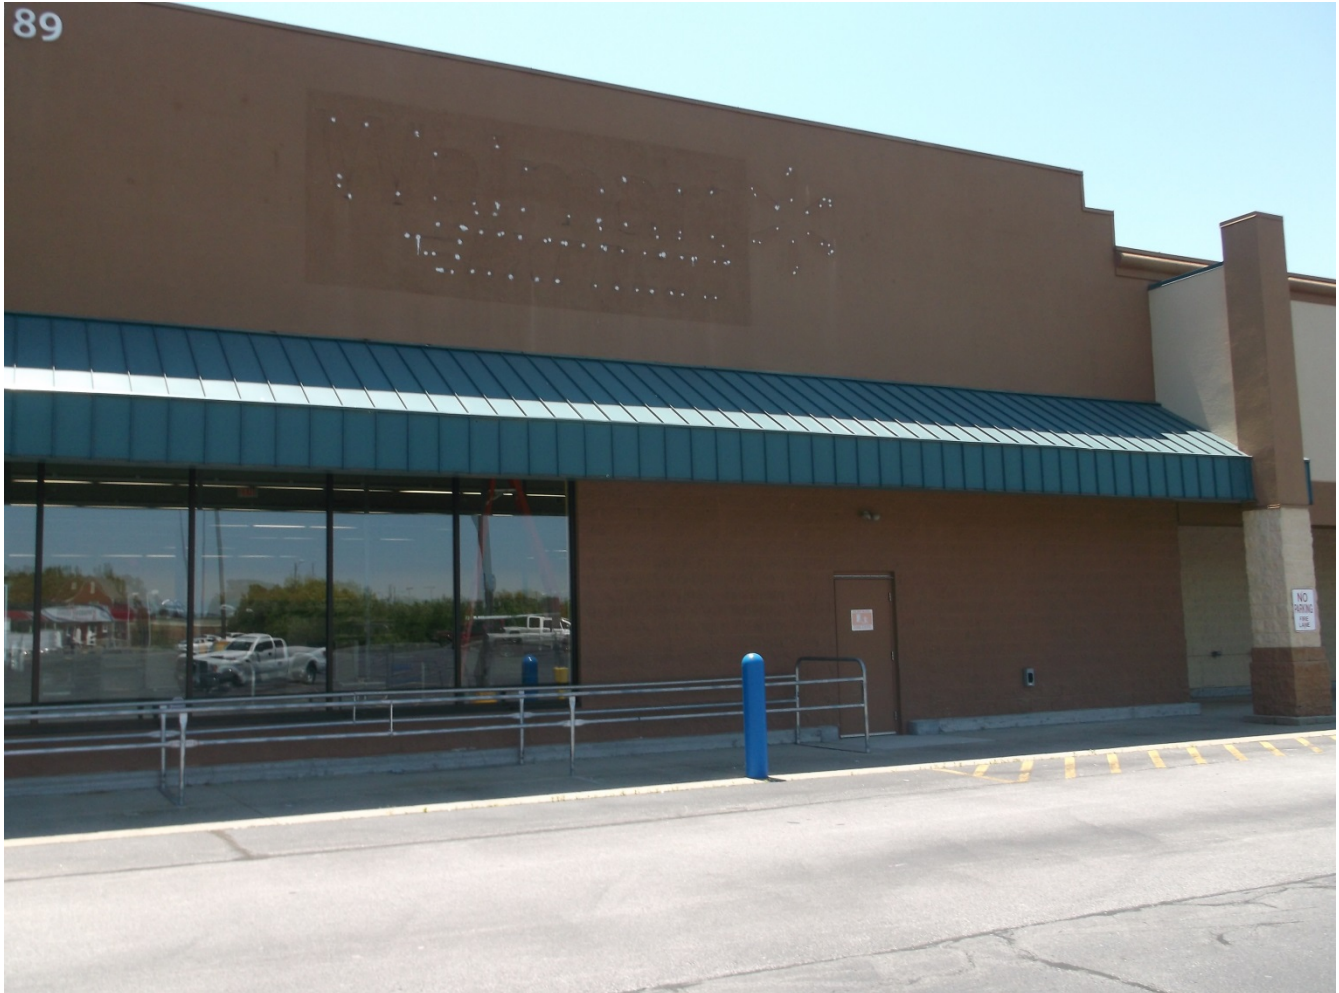
The steel framing in the front of the building extends outward past the storefront and bears on exterior concrete and stone columns along with the front store wall (See Photo #5).

Photo #5 – Exterior view of the brick veneer and metal stud framing behind the storefront.

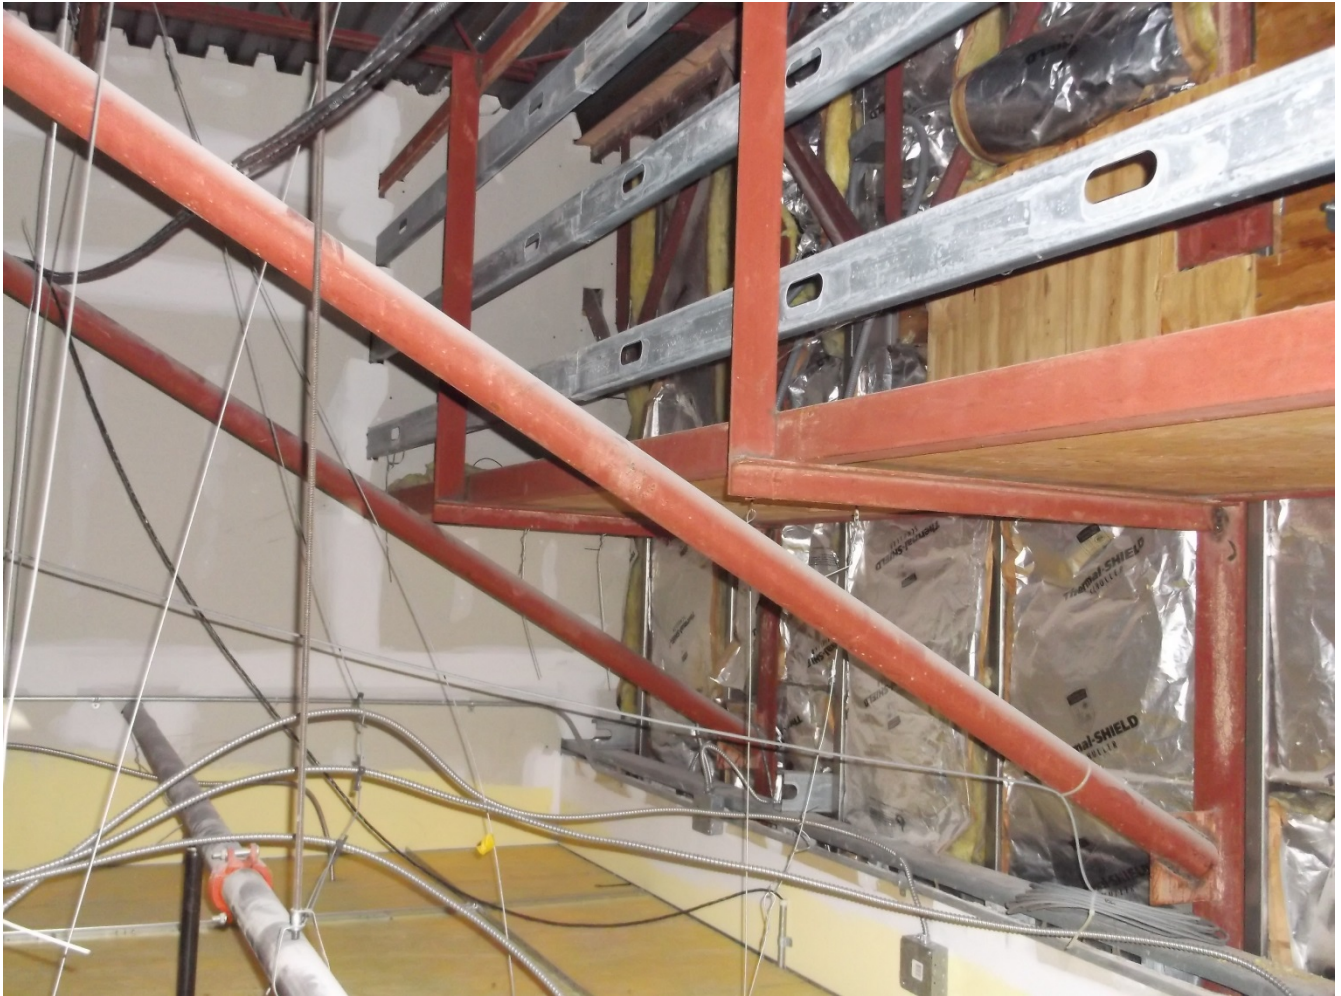
Photo #6 – Inside front storefront wall was an access platform servicing the front of the building. Steel vertical beams with 3” diameter pipes extended back at each joist location – around 5’-3” on center.

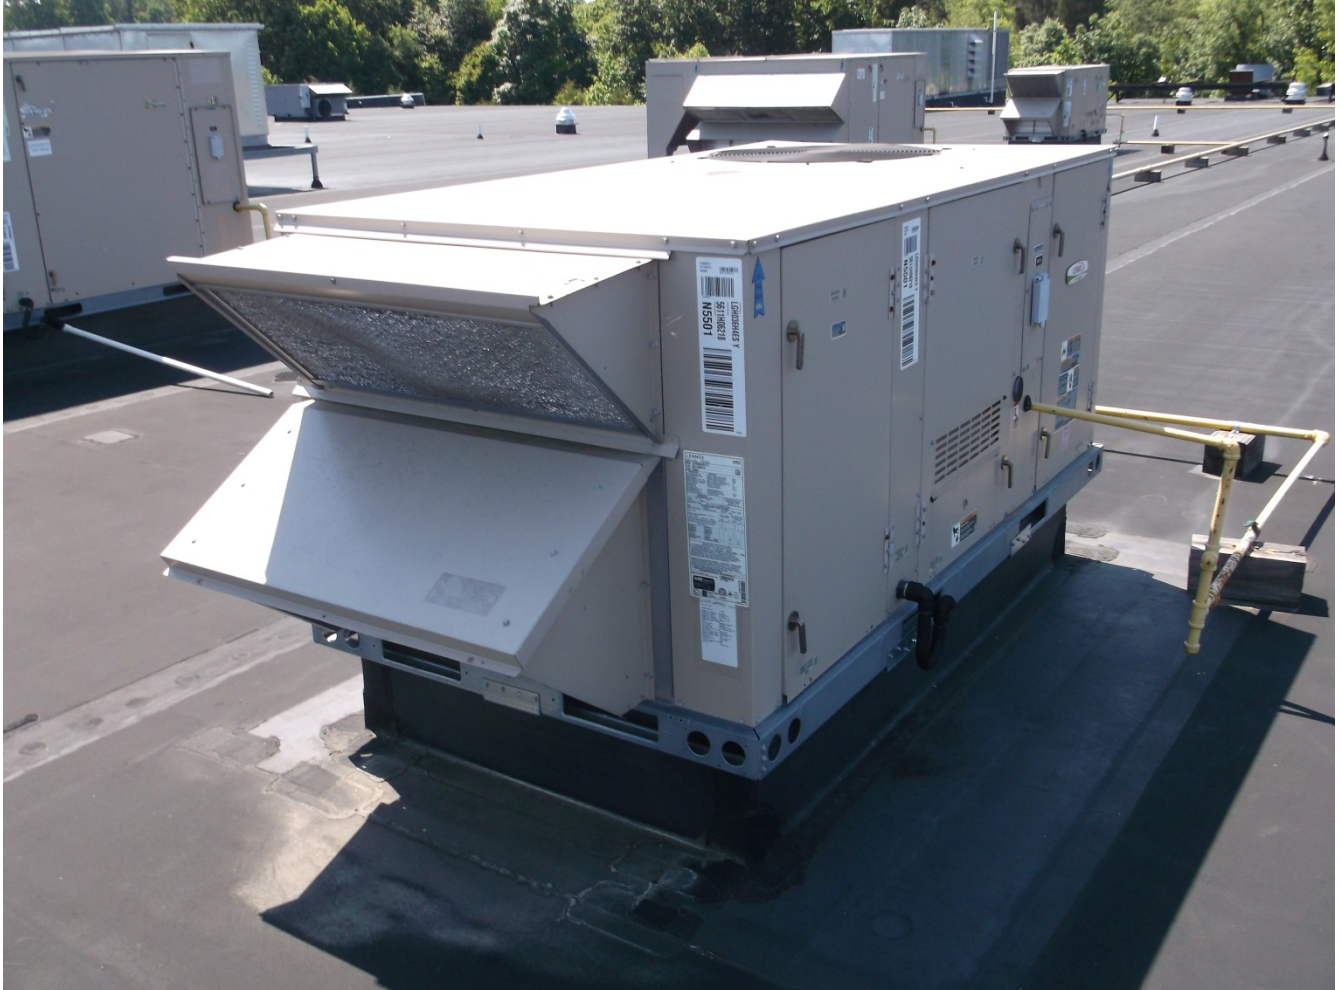
There are four existing Lennox RTU's currently on the roof along with a Carrier RTU, however the Carrier and one of the Lennox RTU's will not be above the proposed Dollar Tree unit (See Photo #7). None of the Lennox units are identical, yet they seem to be in good condition. They are typically situated front to rear of the building and are supported by steel bar joists below. Please note that steel angles are present between the bar joists at the curb perimeter. If new RTU's are to be provided, we recommend putting them at these locations. Also, please note that there is a steel angle frame on the roof as well. There are also two refrigeration units near the store unit: a Kysor/Worren Refrigeration unit and a Seasons 4 Refrigeration unit. The Seasons 4 unit is at the back of the marketplace and would not be directly above the proposed Dollar Tree store (See Photo #8). The Kysor/Worren unit would be directly above the proposed Dollar Tree store, but seems in good condition (See Photo #9). The unit bears on steel joists below the roof and is structurally sufficient. In addition, there are two old metal beams and angles to hold RTU's in the very back of the roof on the Marketplace. These are very close to the back bearing wall of the store (See Photo #10). We recommend that if Dollar Tree decides to move these in another location or put RTU's on them, to consult with the structural and mechanical engineers. Please note that the roof consists of a membrane and slopes away from the front of the building.

Photo #7 – Existing Lennox RTU’s above the proposed Dollar Tree Store. Two of the newer RTU’s appeared to be in good condition.

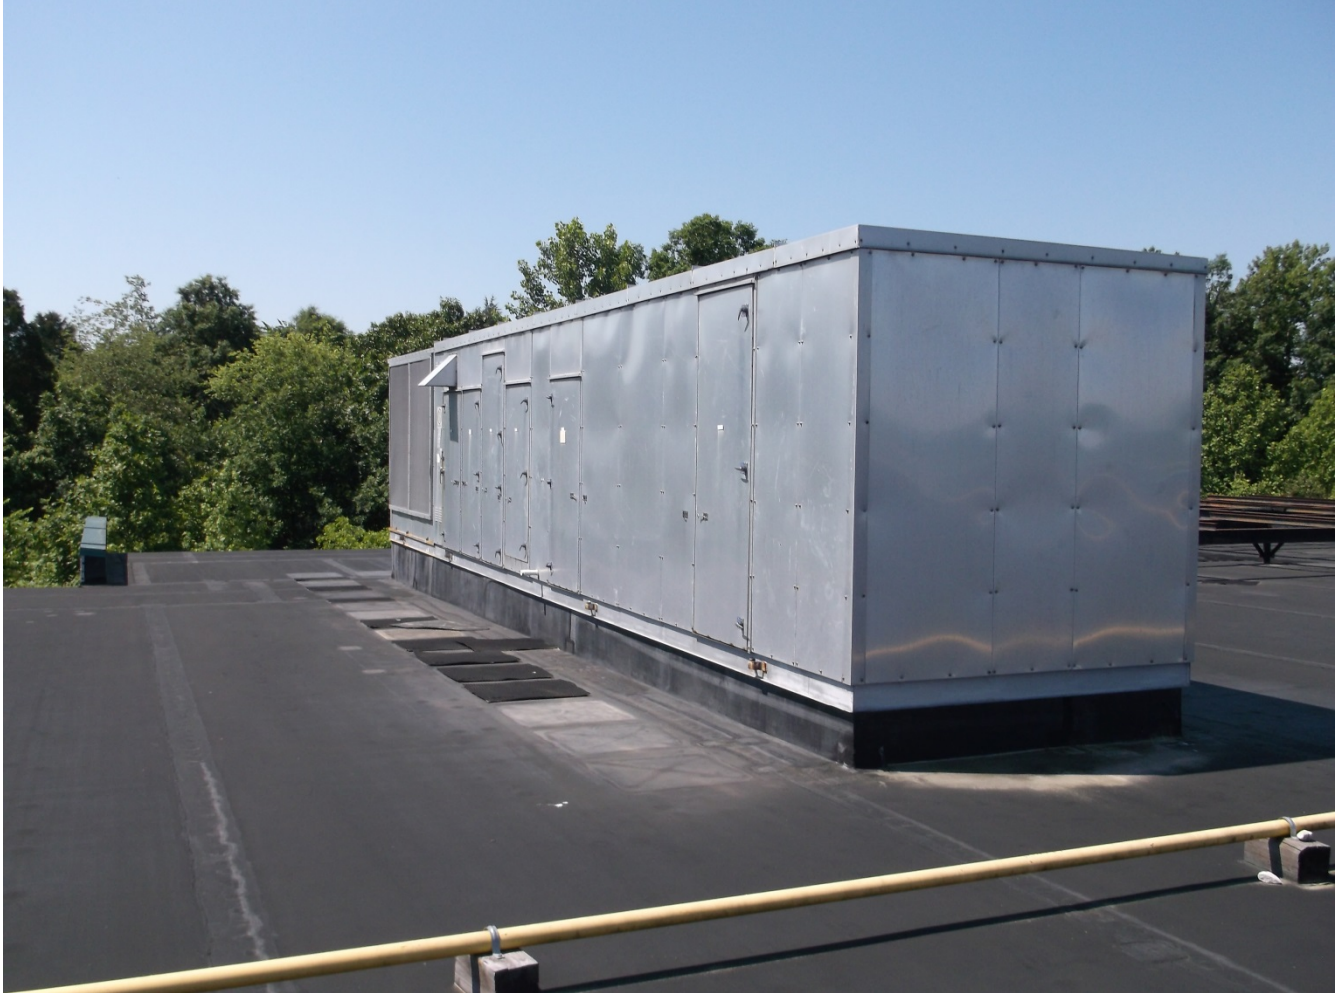
Photo #8 – Seasons 4 Refrigeration Unit Originally for Wynn Dixie.  
This unit is located at the back of the Marketplace.

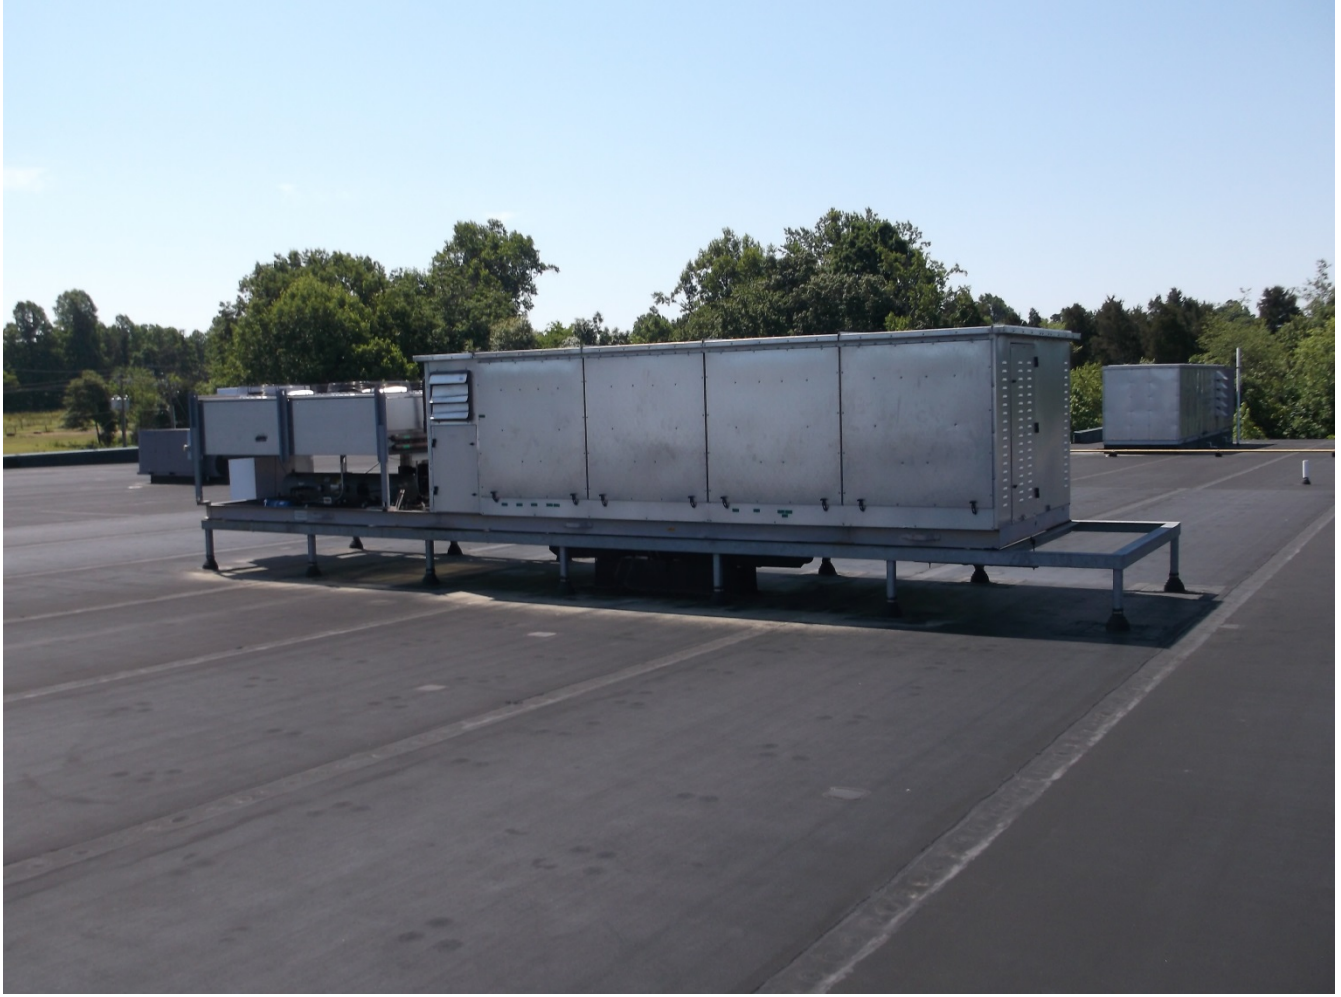
Photo #9 – Kysor/Worren Refrigeration Unit at the front of the proposed Dollar Tree store.

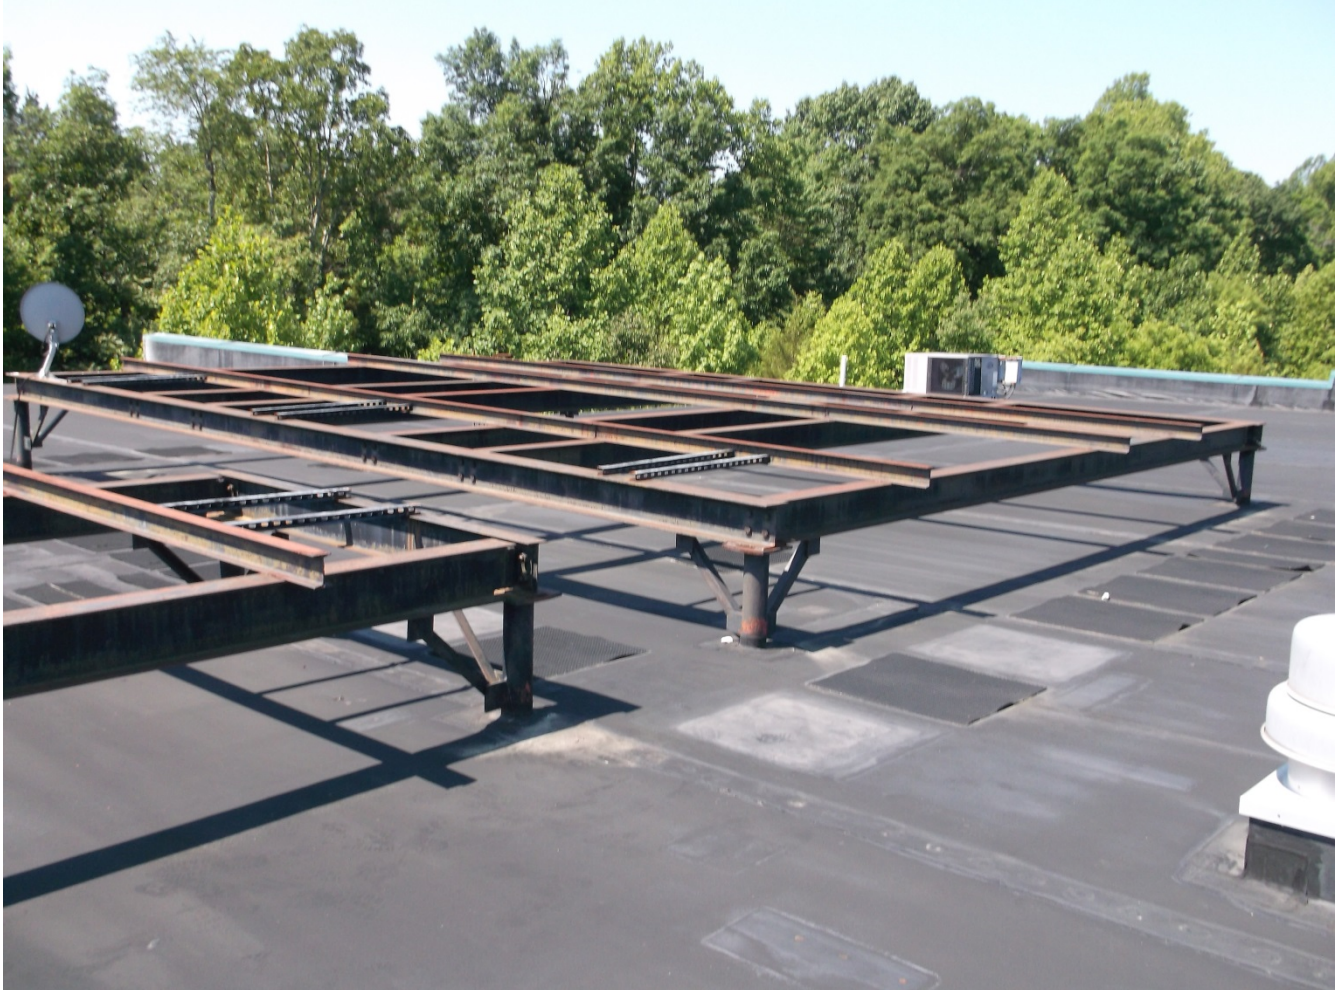
Photo #10 – Steel Beams and Angles that held old RTU’s in back of the Marketplace.

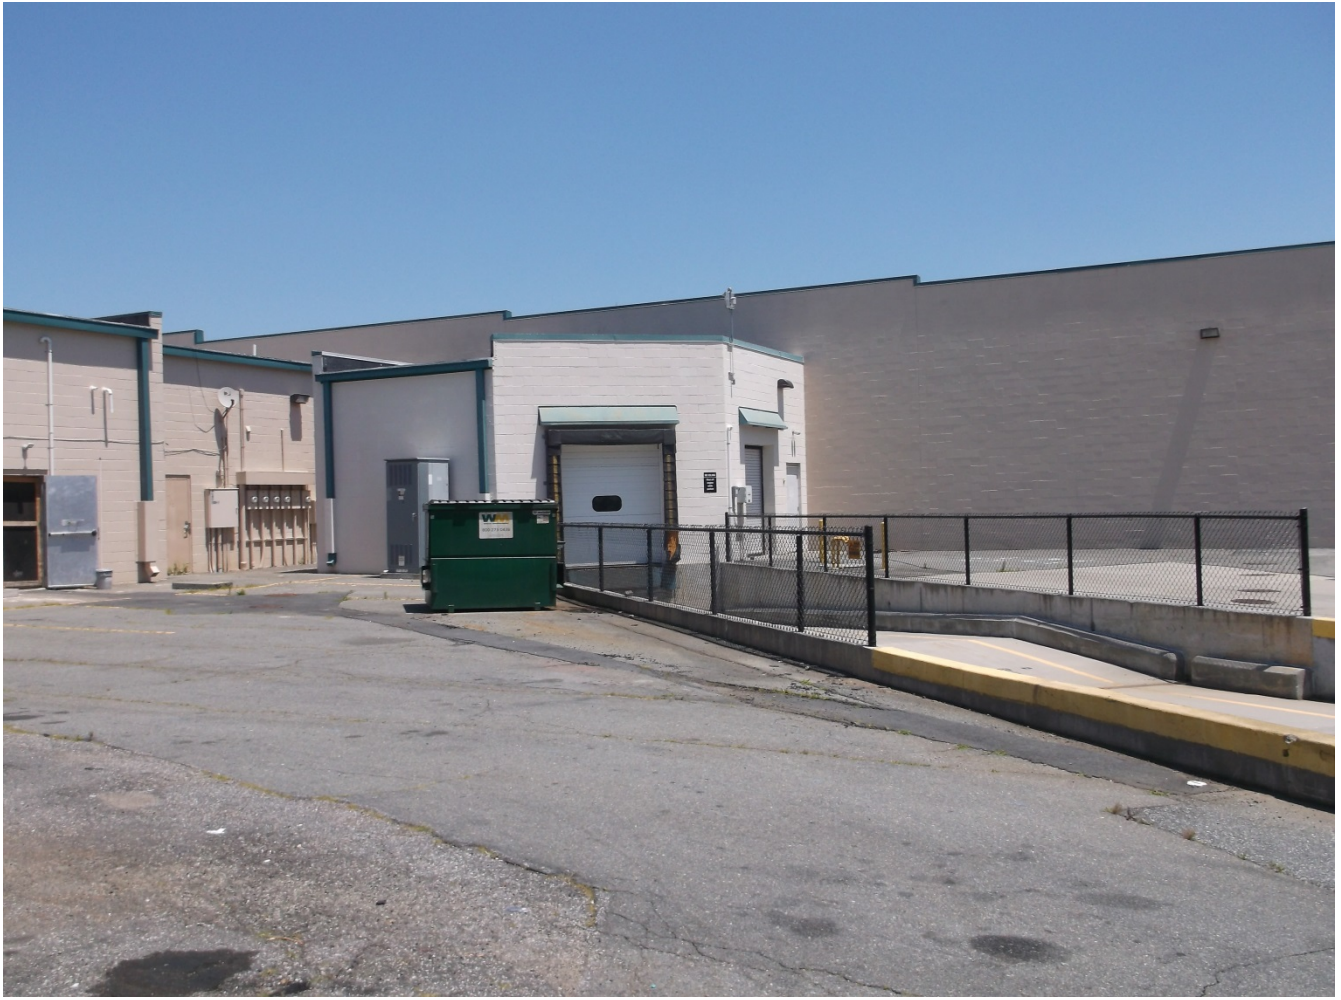
There is also an overhead door access into the rear - side of the building. A concrete slab slopes down to the overhead door approximately 18" – 24" in height (See Photo #11). The ramp seems to meet Dollar Tree standards. In addition, there looks to be sufficient room for trucks to access the rear of the building and the loading dock area.

Photo #11 – Loading Dock Ramp located in the back of the Marketplace. There is sufficient room for trucks to maneuver and back into the loading dock. The ramp drops roughly 18” – 24” from the ground surface.
