W.O. # 158490
 Survey Date 09/17/2016
 Member Name Hamlin Roofing Services, Inc.
 Building Name Advance Auto Parts #103056
 (Asheville, NC)
 Building Address 400 Merrimon Avenue
 City, State & Zip Asheville, NC 28801
 Building Phone No. _____

Advance Auto Parts
#103056 (Asheville, NC)

400 Merrimon Avenue,
Asheville NC

09/17/2016

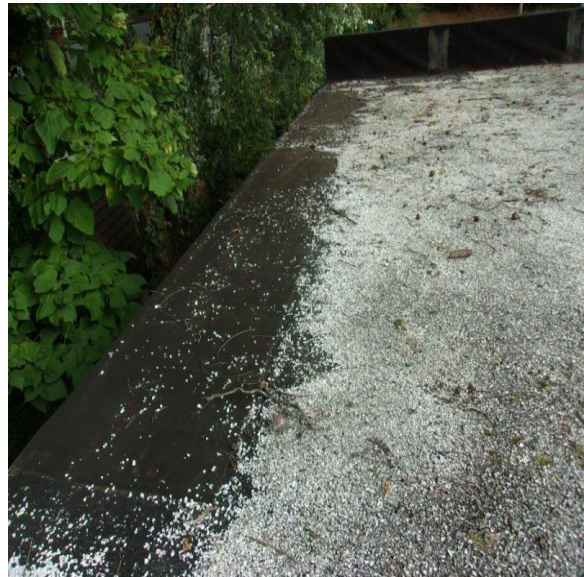
WO#40532_Advance_Auto_-_Asheville_006.jpg
WORKORDER:[WO #158490 (ALT#:40532) (CL#:103056)]

repair area - re=broadcast ballast to this area

Defect 3: re-broadcast ballast

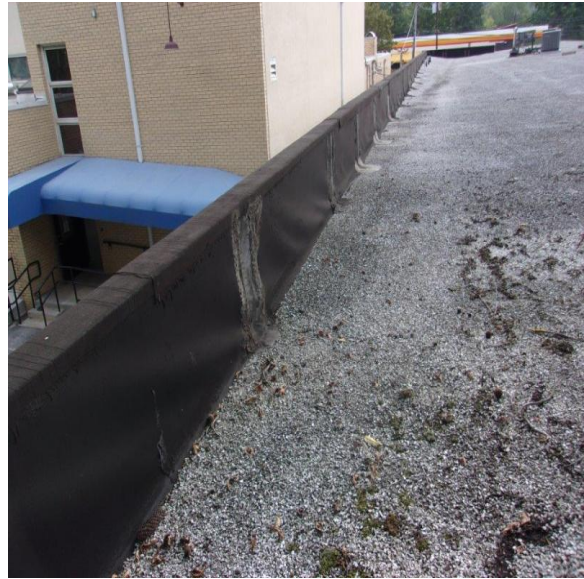
WO#40532_Advance_Auto_-_Asheville_008.jpg
WORKORDER:[WO #158490 (ALT#:40532) (CL#:103056)]

Defect 1: 25 wall flashing joints need to be cut out and re-worked.

open wall flashing joints

#	Roof Defect Description <i>In detail describe the defect. If damaged explain how it appears to have happened.</i>	Recommended Action <i>How will repair be made?</i>	Units /Qty	Class C/PM/W	Cost to Complete	
					Current Year	Next Year
1	Open wall flashing joints	Cut out existing areas weld 15" modified patches	25		\$	\$
2	Debris on roof	Remove debris on roof			\$	\$
3	Ballast missing in areas	Re-broadcast ballast	50 sf		\$	\$
4					\$	\$
Total All Recommended Actions					\$	\$
LABOR	52 hours (2 techs) @ \$89.00				\$4,628.00	\$
Material	Modified membrane				\$598.00	\$
Material					\$	\$
Material					\$	\$
Material					\$	\$
Material					\$	\$
TAX	TAX AS Applicable				\$	\$
Total All Recommended Actions					\$5,226.00	\$

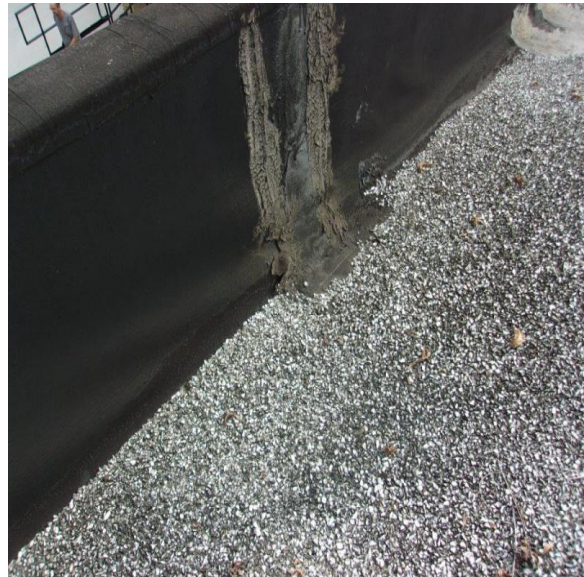
WO#40532_Advance_Auto_-_Asheville_009.jpg
WORKORDER:[WO #158490 (ALT#:40532) (CL#:103056)]

open wall flashing joints

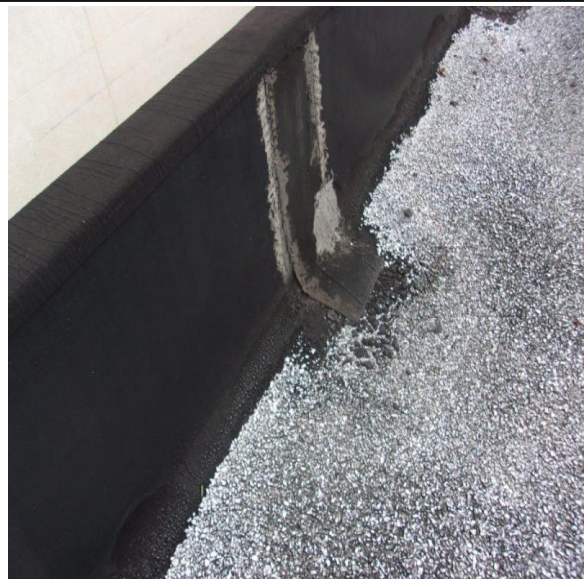
WO#40532_Advance_Auto_-_Asheville_010.jpg
WORKORDER:[WO #158490 (ALT#:40532) (CL#:103056)]

open wall flashing joints

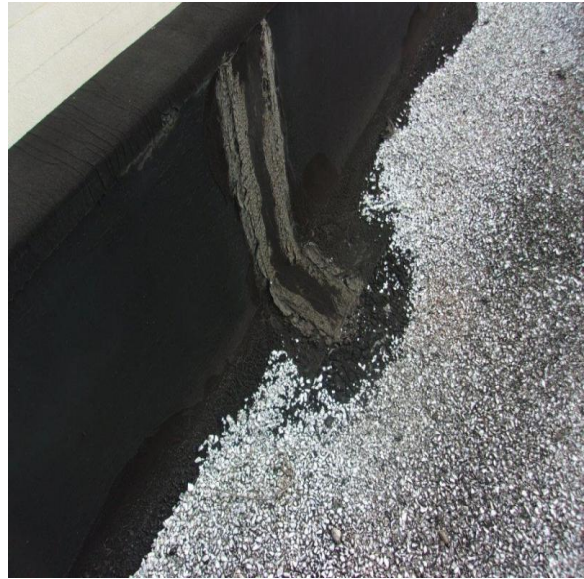
WO#40532_Advance_Auto_-_Asheville_011.jpg
WORKORDER:[WO #158490 (ALT#:40532) (CL#:103056)]

open wall flashing joints

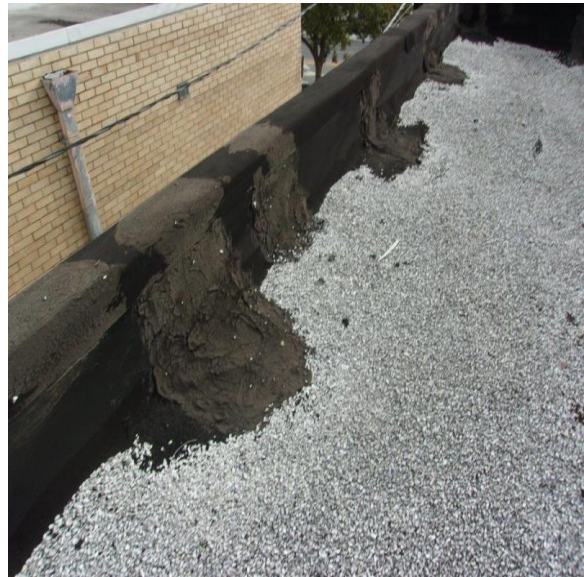
WO#40532_Advance_Auto_-_Asheville_017.jpg
WORKORDER:[WO #158490 (ALT#:40532) (CL#:103056)]

open wall flashing joints

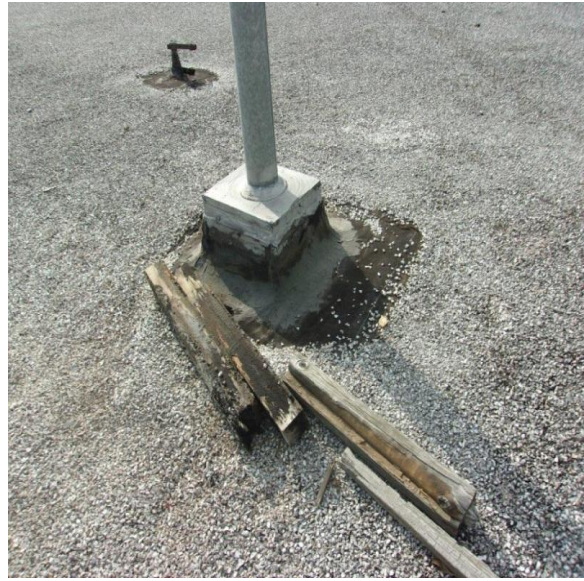
WO#40532_Advance_Auto_-_Asheville_023.jpg
WORKORDER:[WO #158490 (ALT#:40532) (CL#:103056)]

debris on roof

Defect 2: remove debris from roof
