Subject: Hazardous Building Materials Survey for 2500 S Archibald Avenue, Ontario

Re: Asbestos and Lead Sampling– 2500 S. Archibald Avenue, Ontario

This report documents the findings from an asbestos and lead inspection conducted by Aurora Industrial Hygiene, Inc. (Aurora) at the Ontario Police Department building located at 2500 South Archiblad Avenue in Ontario, California on April 30, 2024. The purpose of the survey was to collect samples of specific building materials for asbestos and lead, as requested.

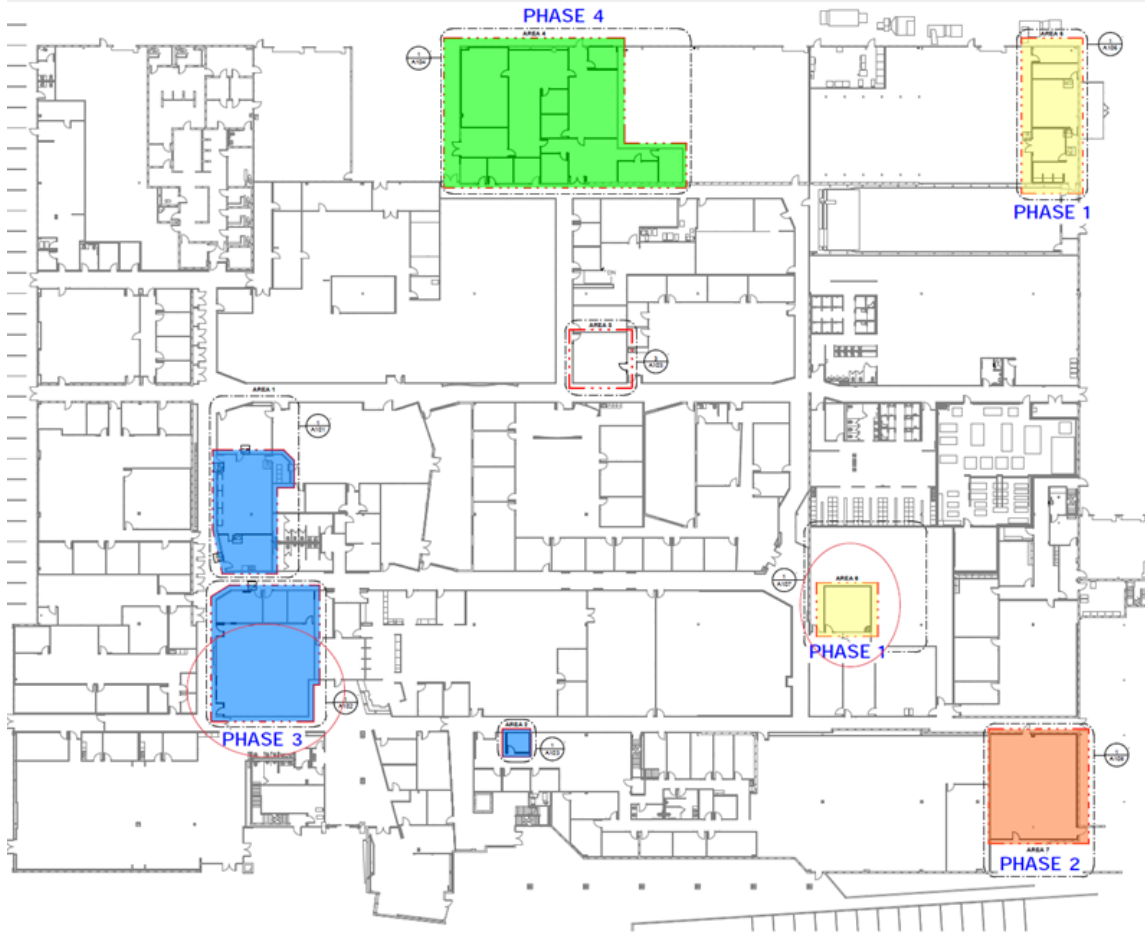
Location Diagram

I hope that this information is helpful. A sample location diagram, pictures, laboratory results and inspector certifications are attached.
